# Facility Condition Assessment

Providence - Alan Shawn Feinstein Elementary at Broad Street

*June 2017*

1450 Broad Street, Providence, RI 02905

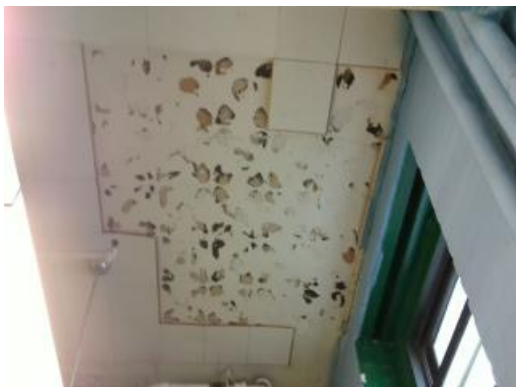
Basement Adhered Ceiling

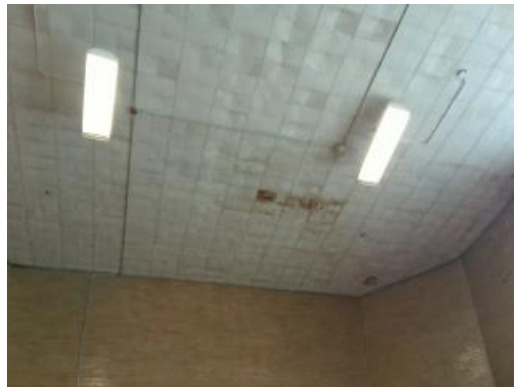
Adhered Ceiling

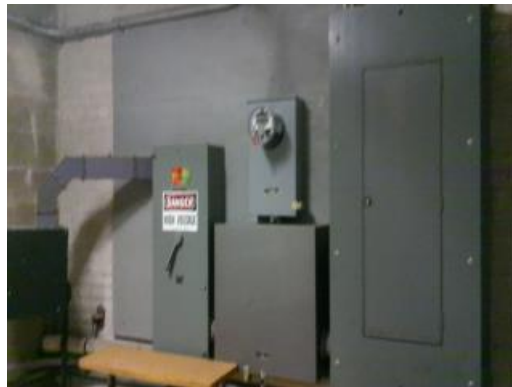
Main Distribution Panel

Uniformat Description	LC Type Description	Qty	UoM	Repair Cost	Remaining Life
Lighting Fixtures	Building Mounted Fixtures (Ea.)	8	Ea.	\$12,086	3
Electrical Service	Switchgear - Main Dist Panel (600 Amp)	1	Ea.	\$19,515	5
<b>Sub Total for System</b>		<b>2</b>	<b>items</b>	<b>\$31,601</b>

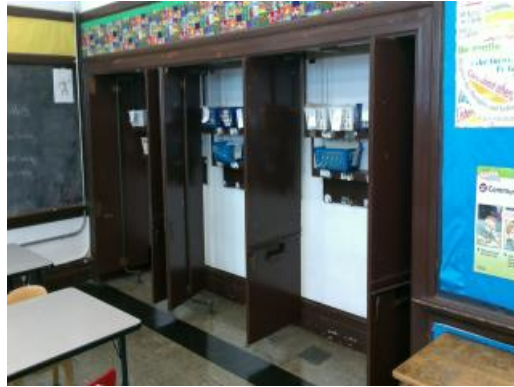
Uniformat Description	LC Type Description	Qty	UoM	Repair Cost	Remaining Life
Casework	Fixed Cabinetry	11	Room	\$124,565	3
Note: Original bookcases and coat closets					
Sub Total for System		1	items	\$124,565	
Sub Total for Building 01 - Main Building		30	items	\$6,156,371	
Total for: Alan Shawn Feinstein Elementary at Broad Street		32	items	\$6,292,093

Original Coat Closet
