Facility Condition Assessment

Tiverton - Tiverton High School

June 2017

100 North Brayton Road, Tiverton, RI 02878

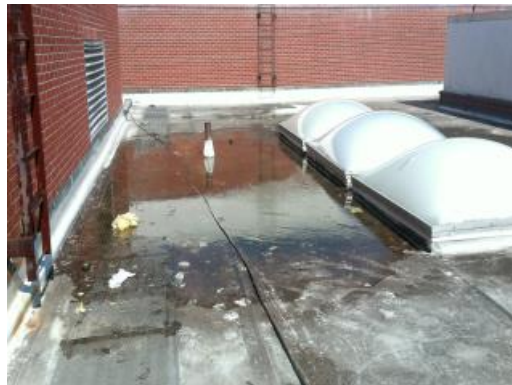
Ponding On Roof

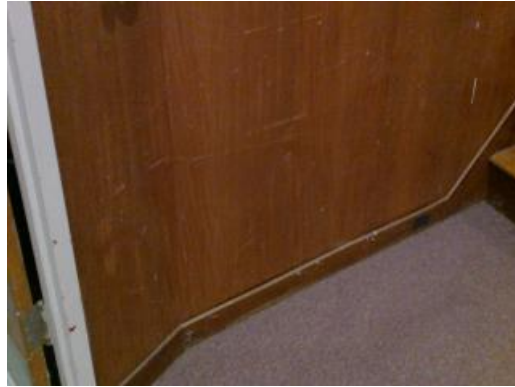
Scratched And Delaminating Wood Wall

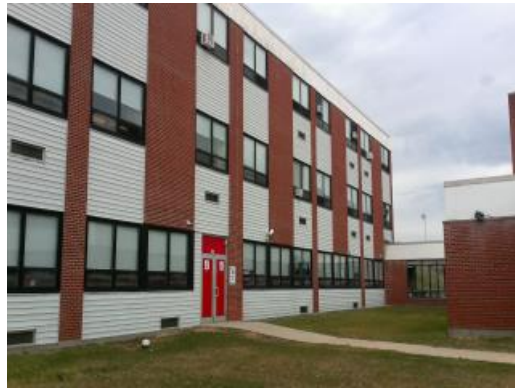
Typical Window Condition

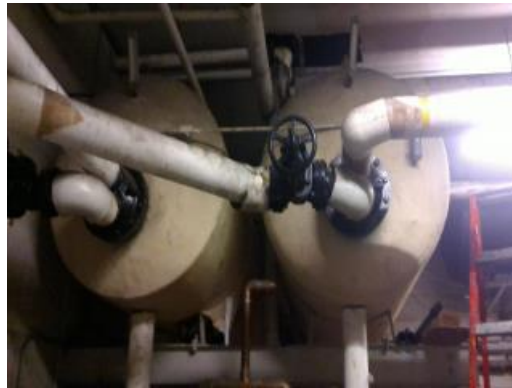
Original Water Storage Tank

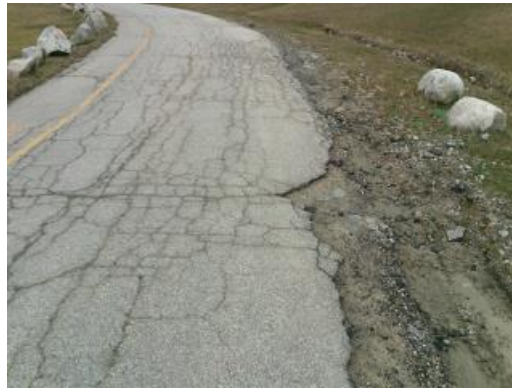
East Roadway Asphalt Paving

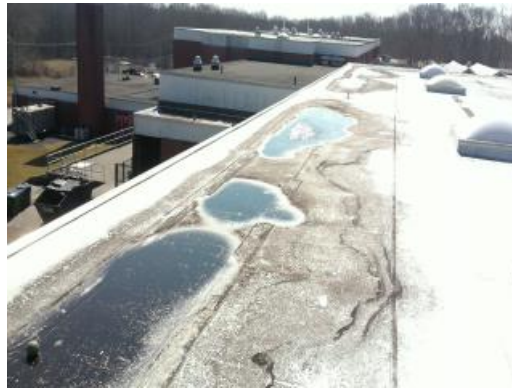
Ponding At Roof Edge

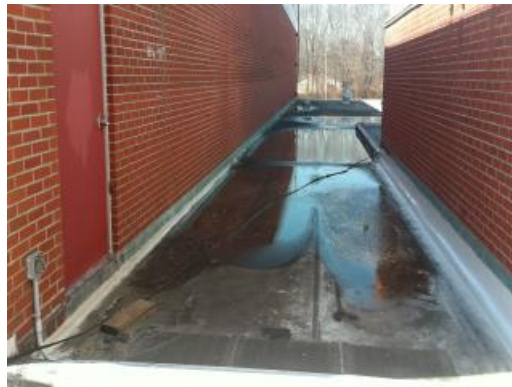
Ponding On Low Roof Above Music Room
