Facility Condition Assessment

Warwick - Warwick Veterans Memorial Junior HS

June 2017

2401 West Shore Road, Warwick, RI 02889

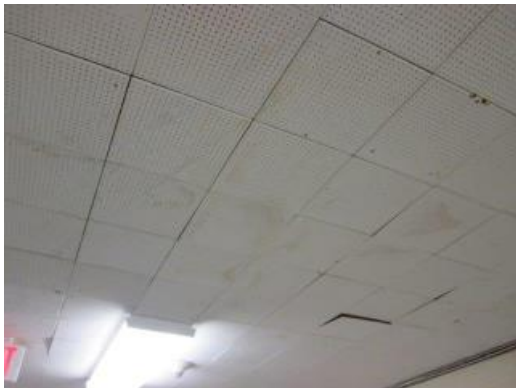
Adhered Ceiling Tiles

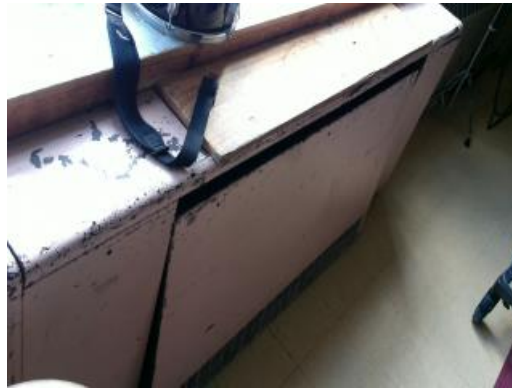
Old Unit Ventilator

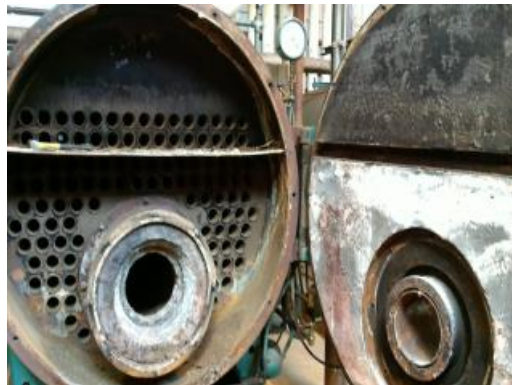
Boiler Out Of Service
