West Warwick - West Warwick Senior High School

June 2017

1 Webster Knight Drive, West Warwick, RI 02893

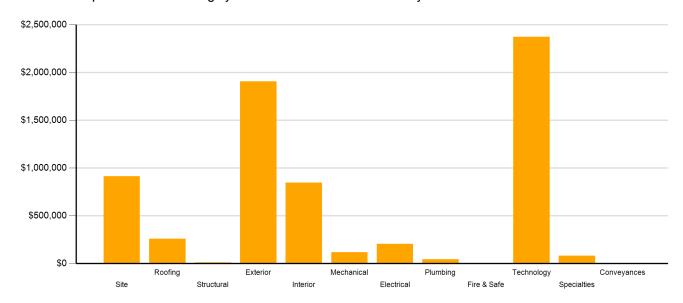
The chart below represents the building systems and associated deficiency costs.

Figure 2: System Deficiencies

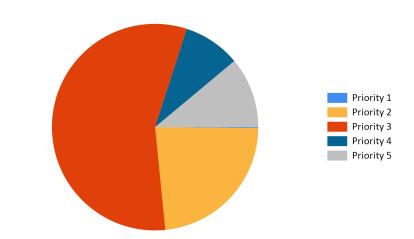
Figure 3: Current deficiencies by priority

Category	1	2	3	4	5	Total
Acoustics	-	-	-	-	-	\$0
Barrier to Accessibility	-	-	-	-	-	\$0
Capital Renewal	\$9,903	\$1,568,404	\$1,432,516	\$324,596	-	\$3,335,420
Code Compliance	-	-	-	-	-	\$0
Educational Adequacy	-	-	\$38,788	\$229,943	\$745,564	\$1,014,295
Functional Deficiency	-	-	-	-	-	\$0
Hazardous Material	-	-	-	\$48,941	-	\$48,941
Technology	-	-	\$2,336,467	-	-	\$2,336,467
Traffic	-	-	\$5,704	-	-	\$5,704
Total	\$9,903	\$1,568,404	\$3,813,476	\$603,480	\$745,564	\$6,740,827
