Facility Condition Assessment

June 2017

Austin T. Levy School, located at 135 Harrisville Main Street in Harrisville, Rhode Island, was built in 1958. It comprises 42,600 gross square feet. Each school across the district was visited three times during the Facility Condition Assessments by three teams of specialists in the spring/summer of 2016.

Burrillville - Austin T. Levy School

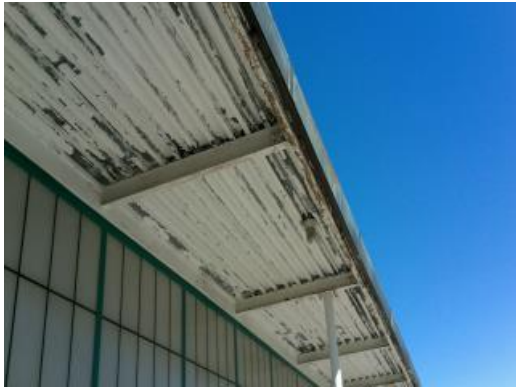
Canopy Awning

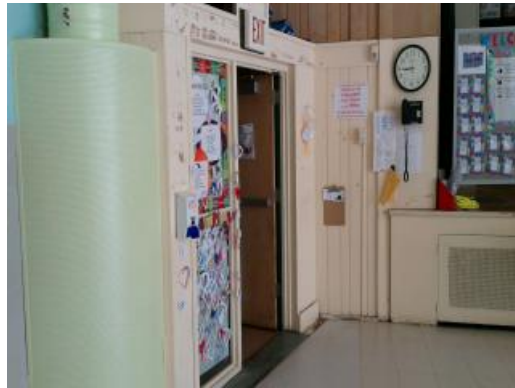
Repaint

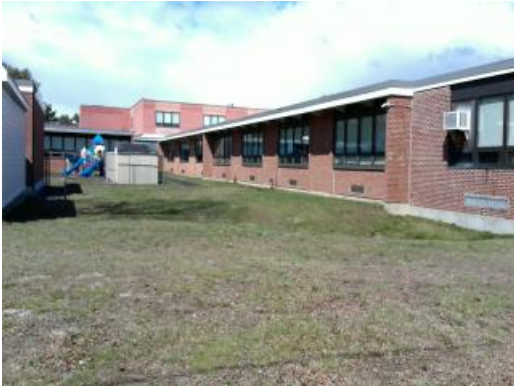
Exterior Finishes

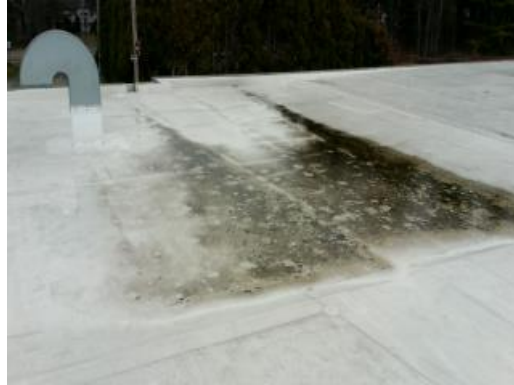
Damaged EPDM

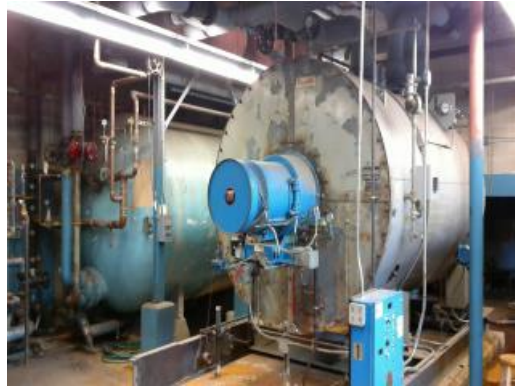
Aged Boilers

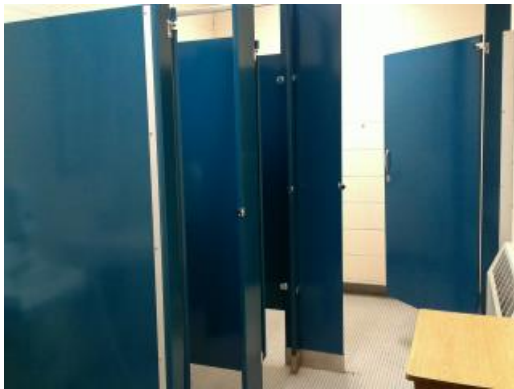
Restroom Wall Panels And Doors

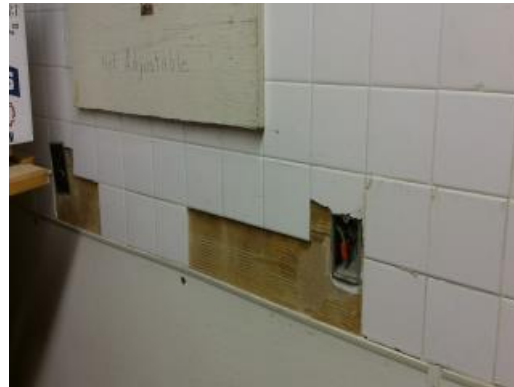
Damaged Tile

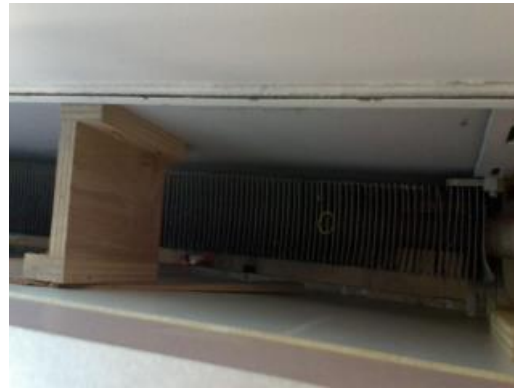
Exposed Fin Tube Behind Book Shelves

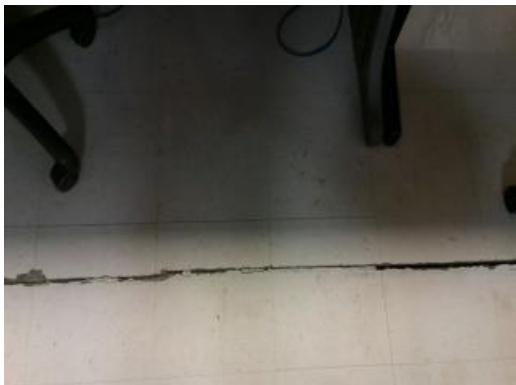
Damaged VCT

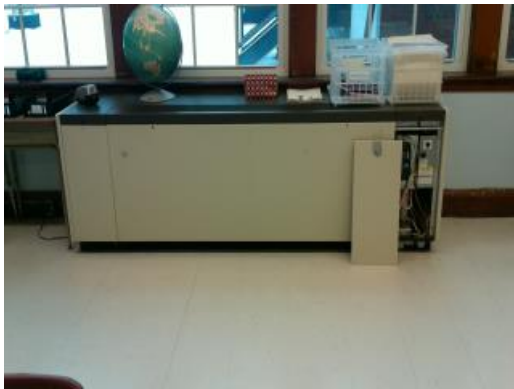
Cabinet Heater

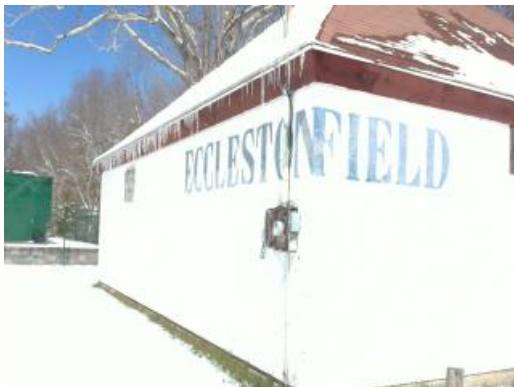
Repaint Exterior

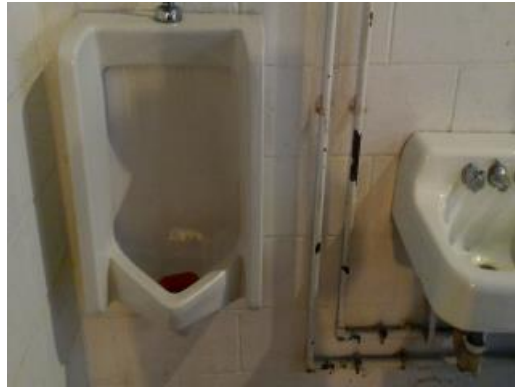
Plumbing Fixtures

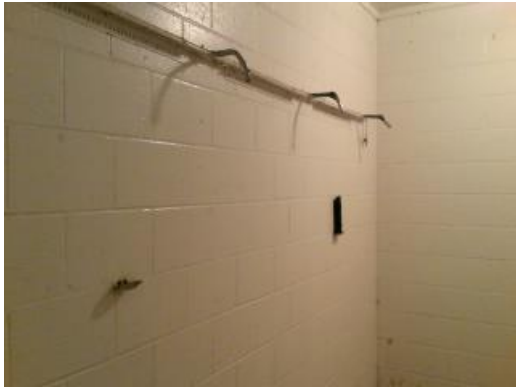
Deficiency	Category	Qty	UoM	Priority	Repair Cost	ID
The Showers Plumbing Fixtures Require Replacement	Capital Renewal	8	Ea.	3	\$65,915	8713
Note: The shower system is beyond useful life. Each shower head should have its own control valve in order to conserve water.						
	Sub Total for System	1	items		\$65,915

Shower Heads
