Exeter-West Greenwich totals 309,120 square feet and consists of the school type(s) detailed below. School(s) were visited three times during the Statewide Facilities Assessment by teams of specialists in March 2016. This report provides LEA summary findings for the statewide assessment program.

# Exeter-West Greenwich

# Facility Condition Assessment

Exeter-West Greenwich - Exeter-West Greenwich Regional High School

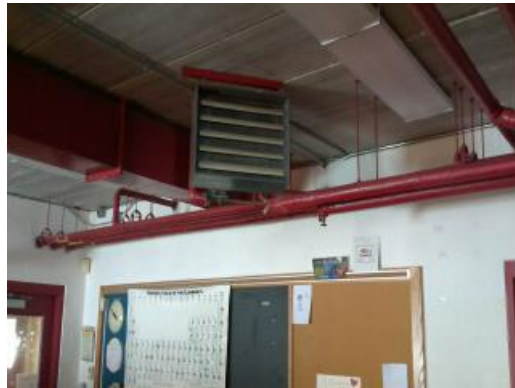
Main Building - Unit Heater

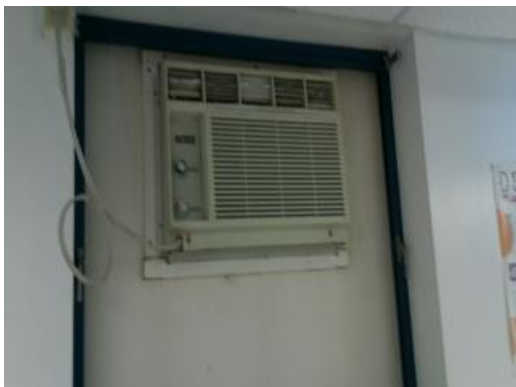
Main Building - Window Unit

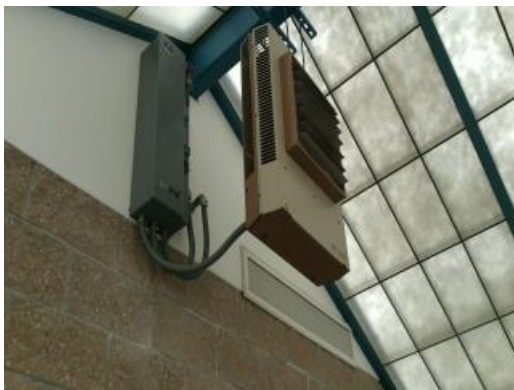
Main Building - Electric Unit Heater

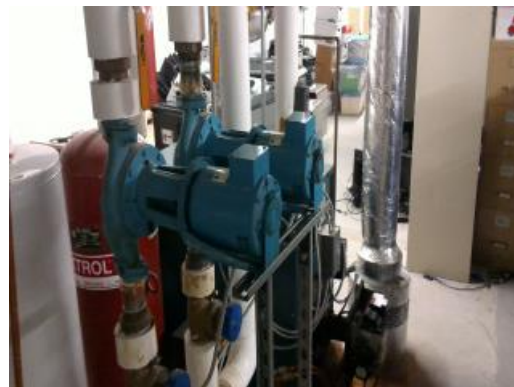
Building 02 - Pumps

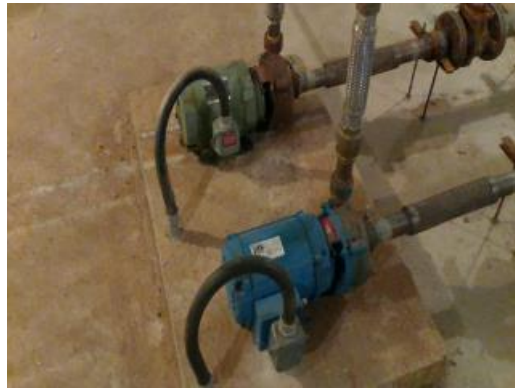
Building 04 - Pumps

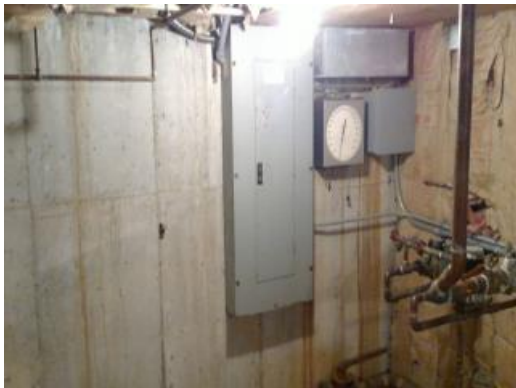
Building 04 - Panelboard

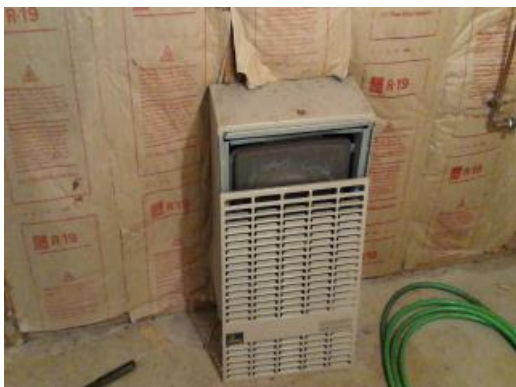
Building 04 - Radiator

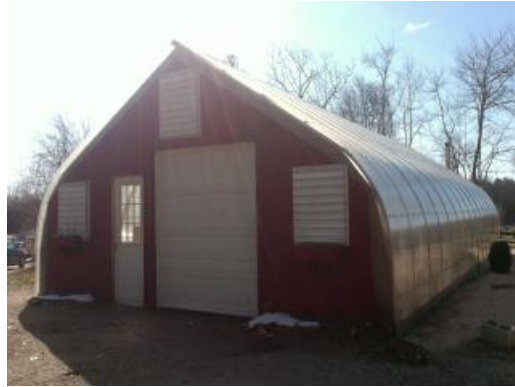
Greenhouse - Exterior

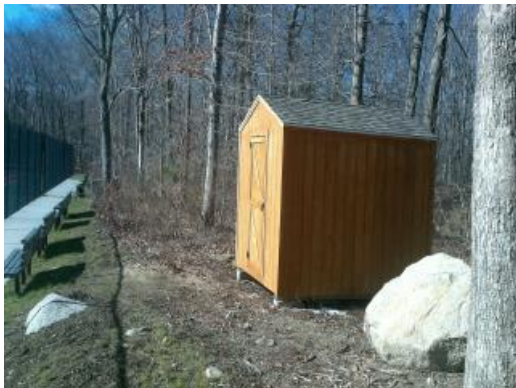
Tennis Storage - Exterior

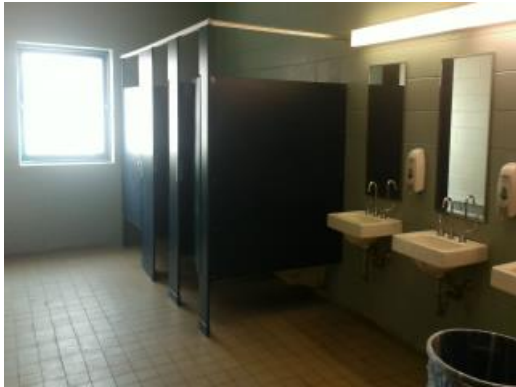
Restroom Fixtures And Finishes

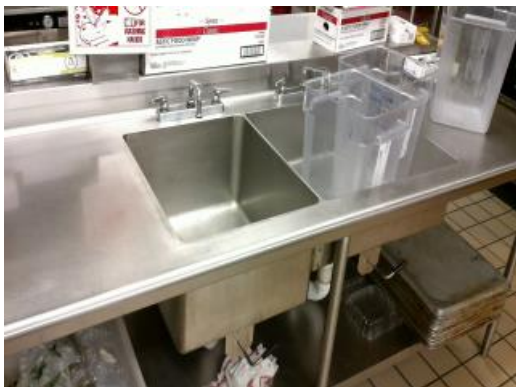
Kitchen Sink

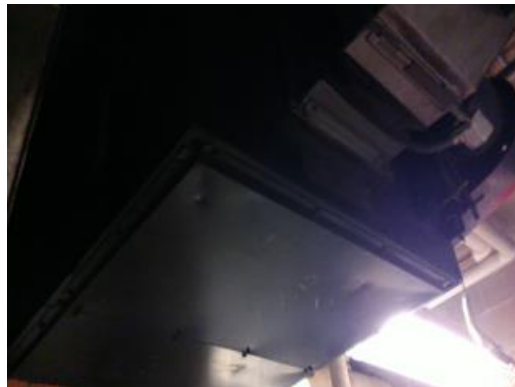
Make-up Air Unit

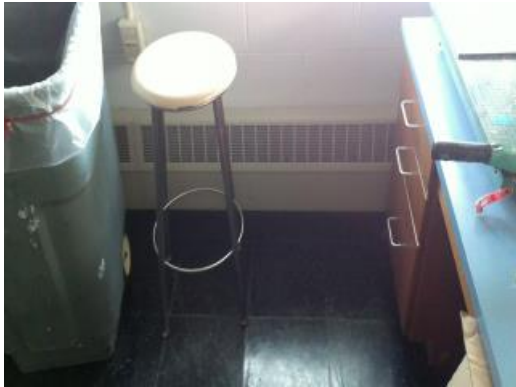
Radiant Heater

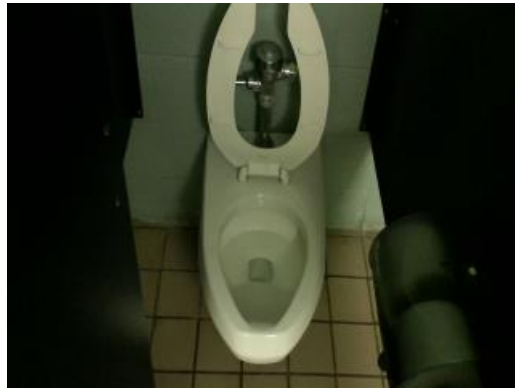
Typical Toilet Fixture

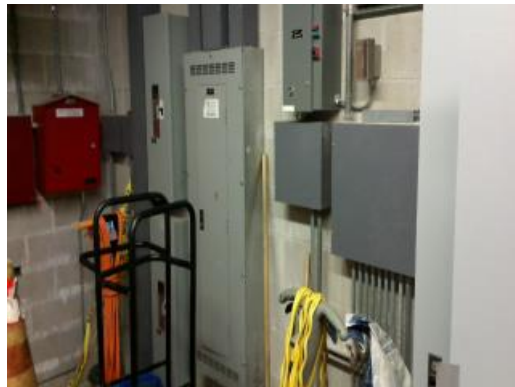
Electrical Panels

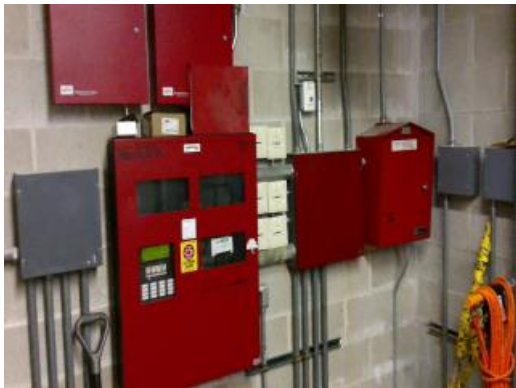
Fire Alarm Panel

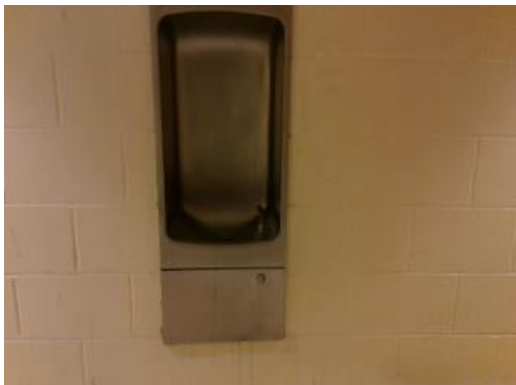
Non-Refrigerated Drinking Fountain

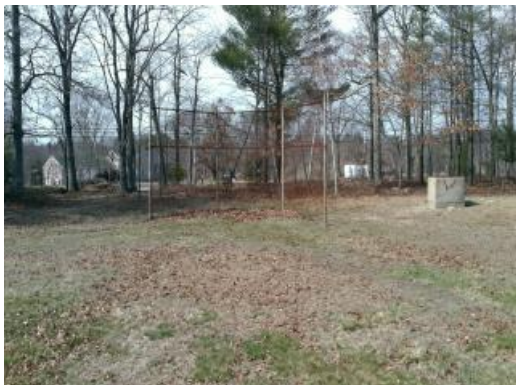
Rusted Fencing

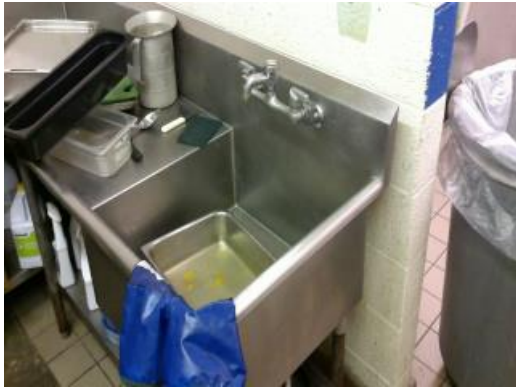
Original Kitchen Sink

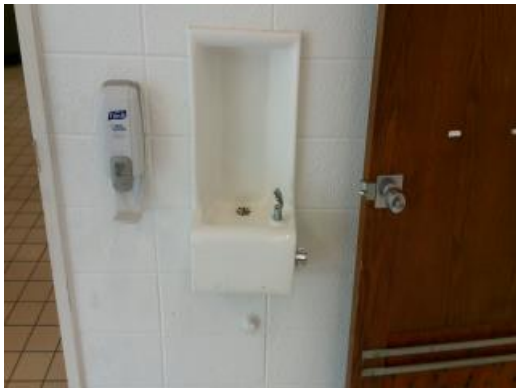
Aged Non-Refrigerated Drinking Fountain

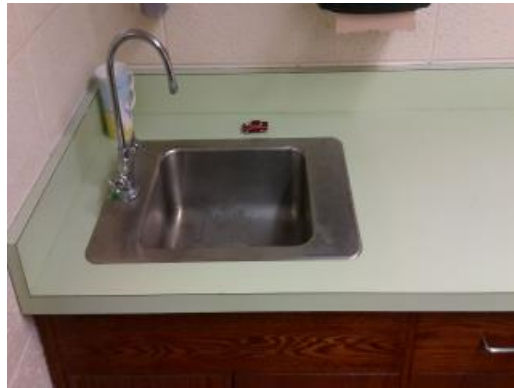
Classroom Lavatory

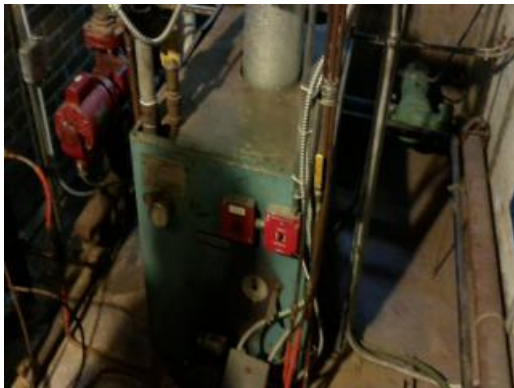
Aged Boiler

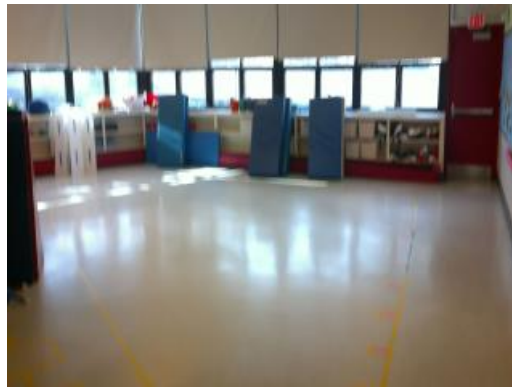
Gym

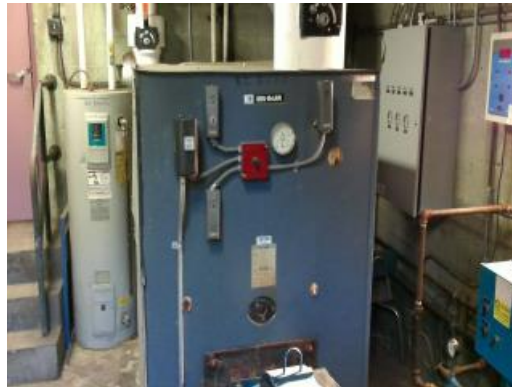
Original Boiler

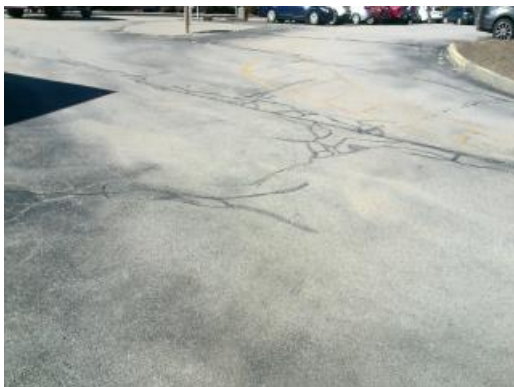
Cracked Asphalt Paving

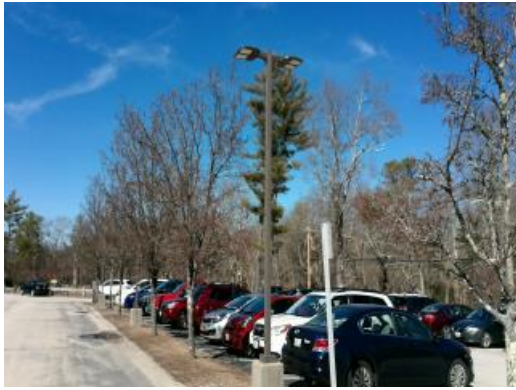
New LED Parking Lights

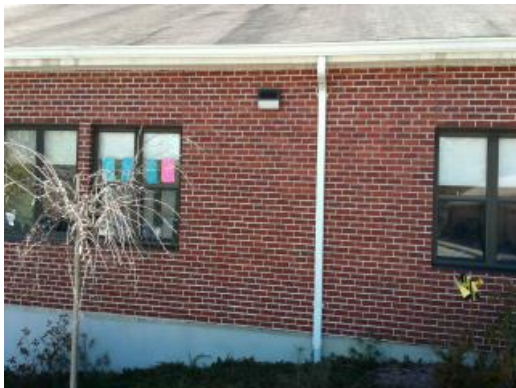
Older Building Lights

Uniformat Description	LC Type Description	Qty	UoM	Repair Cost	Remaining Life
Lighting Fixtures	Building Mounted Fixtures (Ea.)	17	Ea.	\$25,374	3
Lighting Fixtures	Light Fixtures (Bldg SF)	40,300	SF	\$239,457	5
		<b>Sub Total for System</b>	<b>2 items</b>	<b>\$264,831</b>

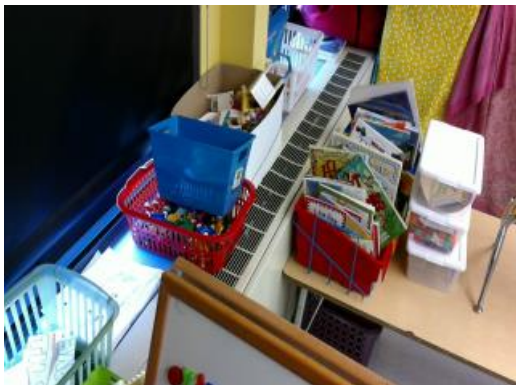
Blocked Vent

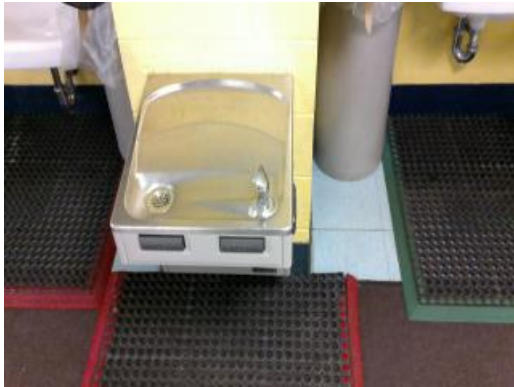
Refrigerated Drinking Fountain

Uniformat Description	LC Type Description	Qty	UoM	Repair Cost	Remaining Life
Plumbing Fixtures	Refrigerated Drinking Fountain	4	Ea.	\$29,510	3
Domestic Water Equipment	Water Heater - Electric - 52 gallon	1	Ea.	\$3,255	3
		<b>Note:</b> 52 gallon electric water heater			
		<b>Sub Total for System</b>	<b>2 items</b>	<b>\$32,765</b>

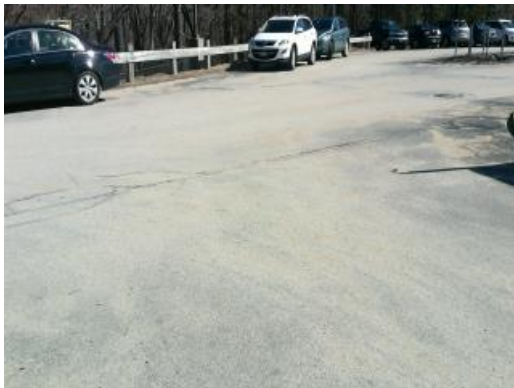
Weathered Asphalt

Uniformat Description	LC Type Description	Qty	UoM	Repair Cost	Remaining Life
Parking Lot Pavement	Asphalt	32	CAR	\$105,873	3
Roadway Pavement	Asphalt	17	CAR	\$56,245	3
		<b>Sub Total for System</b>	<b>2 items</b>	<b>\$162,118</b>	
		<b>Sub Total for Building -</b>	<b>2 items</b>	<b>\$162,118</b>
