Facility Condition Assessment

June 2017

Charter - Highlander Charter School - Lower School (Providence)

Charter - Highlander Charter School - Upper School (Warren)

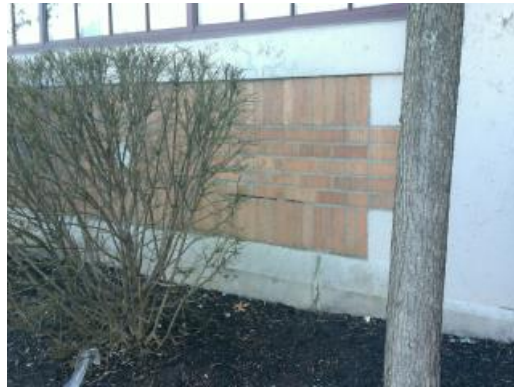
Repointing Needed

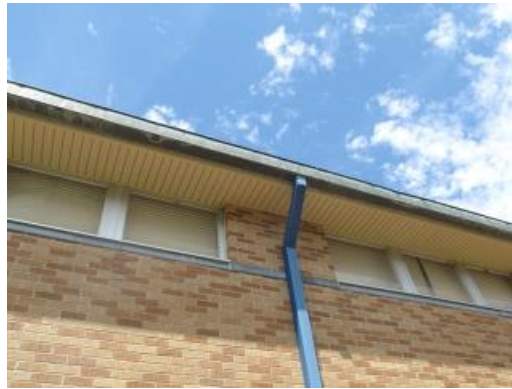
Weathered Gutters
