# North Providence

# Facility Condition Assessment

June 2017

North Providence - Birchwood Middle School

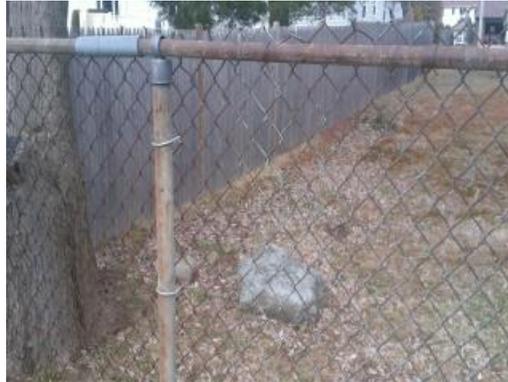
Rusting Baseball Fencing

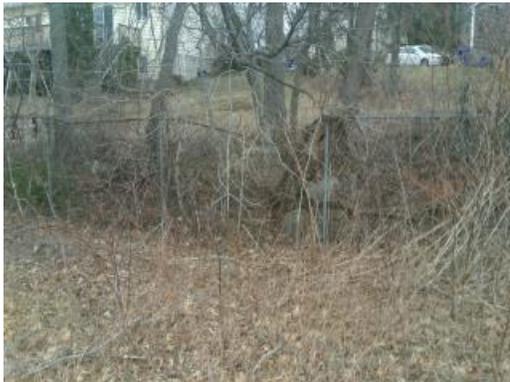
Damaged Fencing

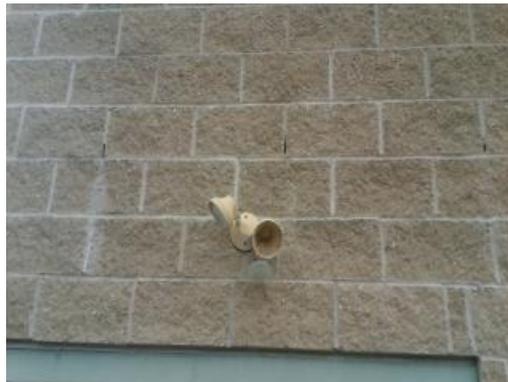
Broken Building Mounted Fixture

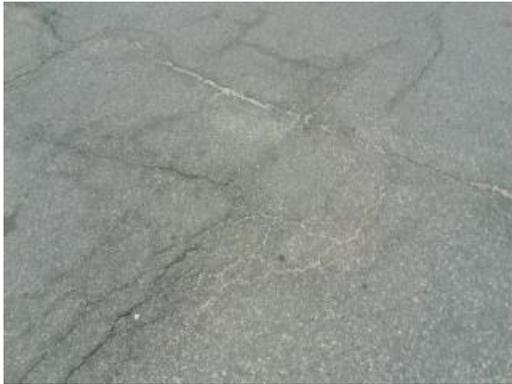
Cracked Parking Lot Asphalt

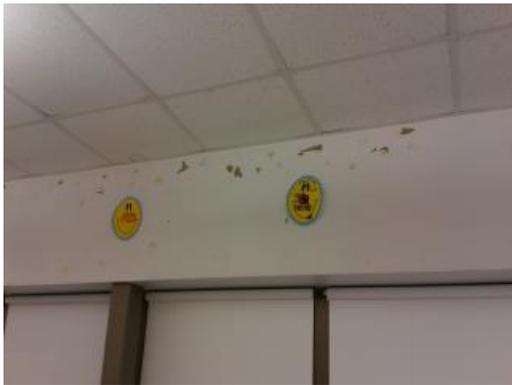
Chipped Wall Paint

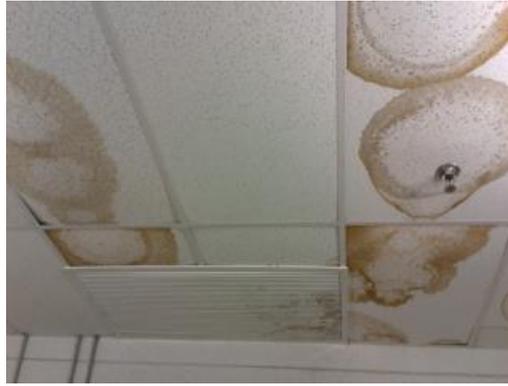
Stained Ceiling Tile

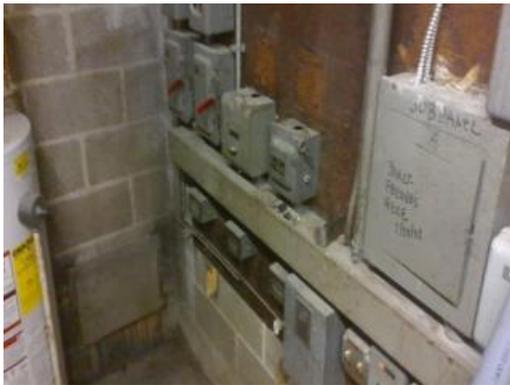
Abandoned Electrical Equipment

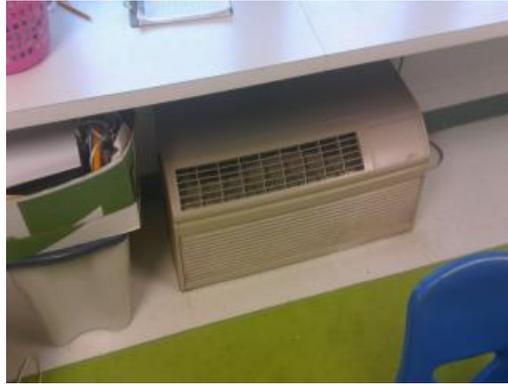
Damaged Thru Wall AC Unit

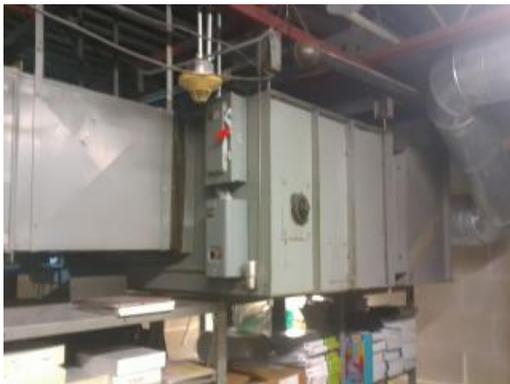
Abandoned AHU

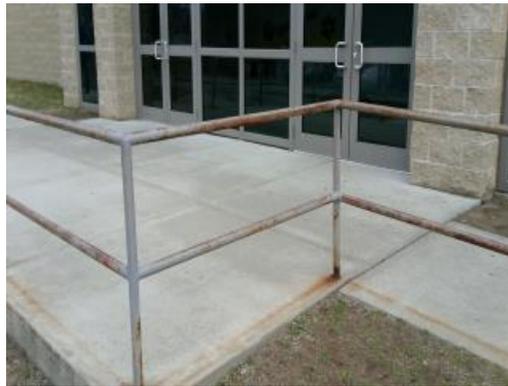
Rusting Handrail

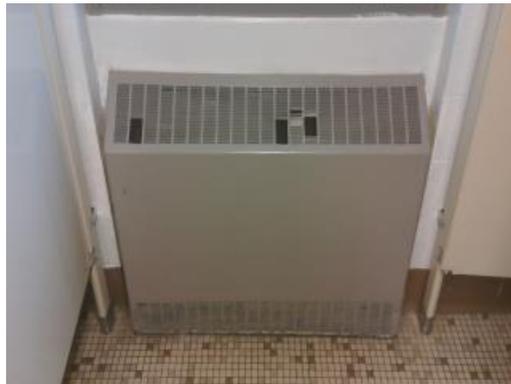
Damaged Fin Tube Radiant Heater

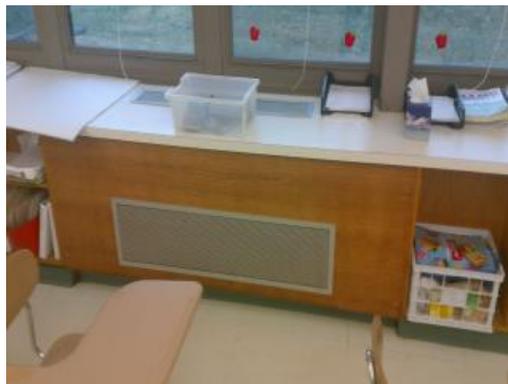
Unit Heater

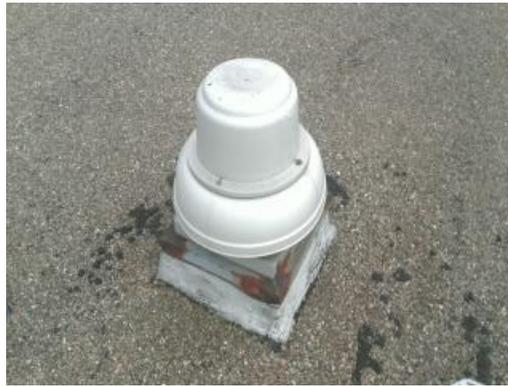
Aged Roof Exhaust

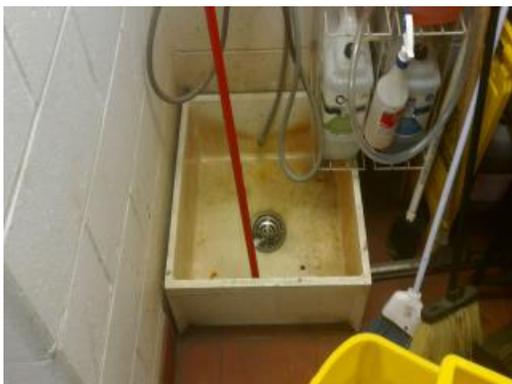
Stained Kitchen Mop Sink

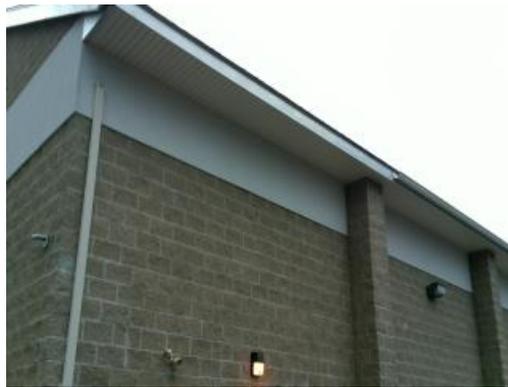
Missing Gutter/Drainpipe

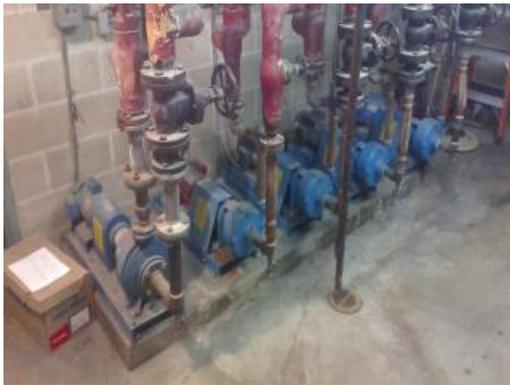
Circulation Pumps Leaking And Overheating

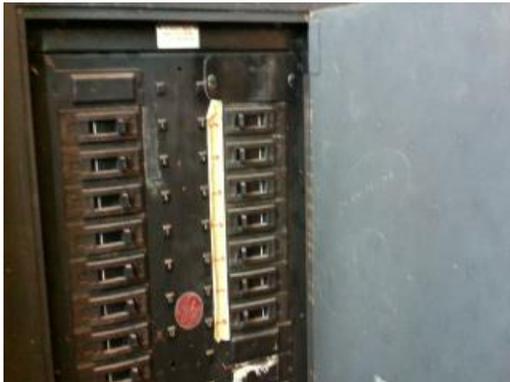
Aged Panelboard

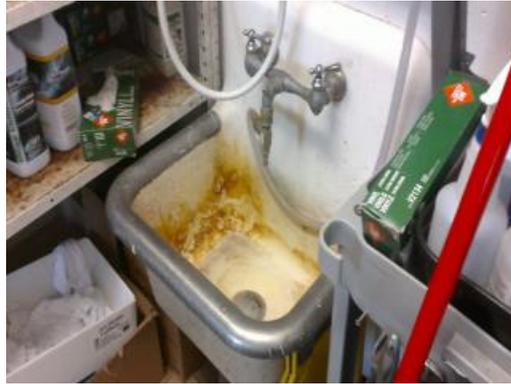
Rusting Custodial Sink

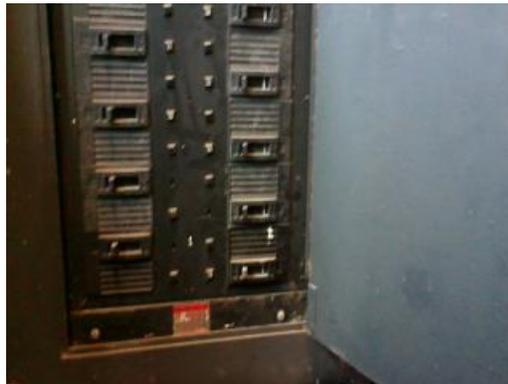
Aged Panelboard

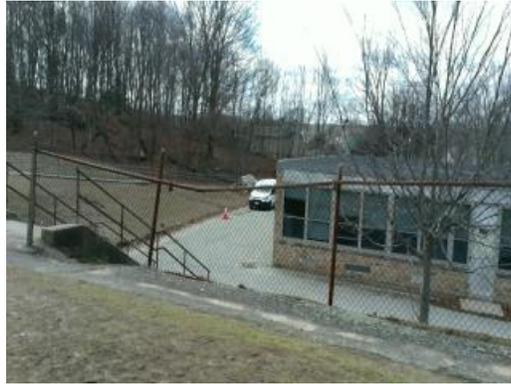
Rusted Chain Link Fence

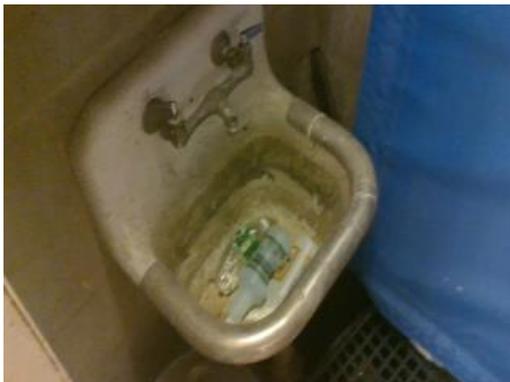
Stained Custodial Sink

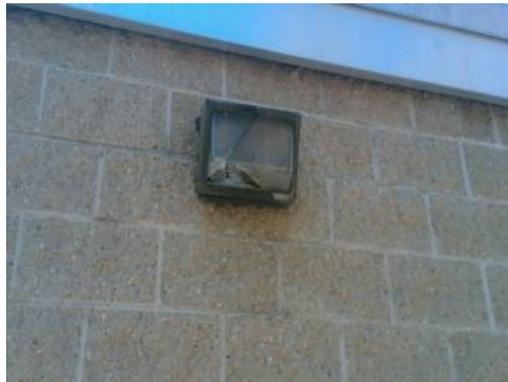
Damaged Building Mounted Light

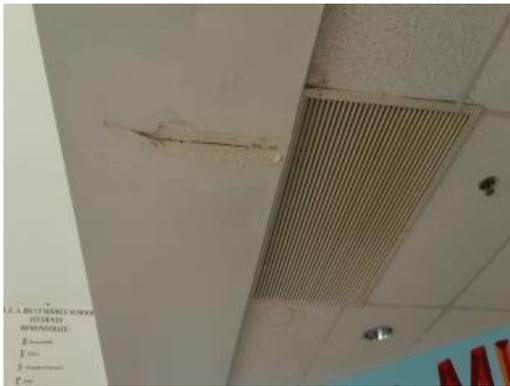
Cracked Gypsum Board Ceiling

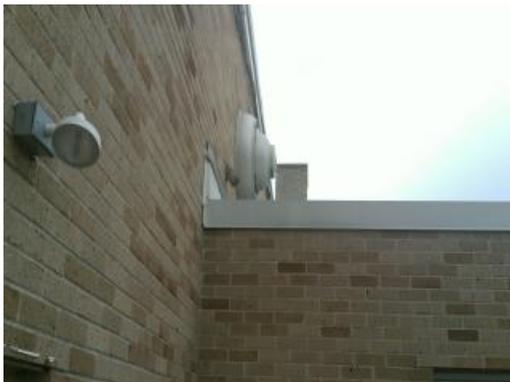
Wall Exhaust Air

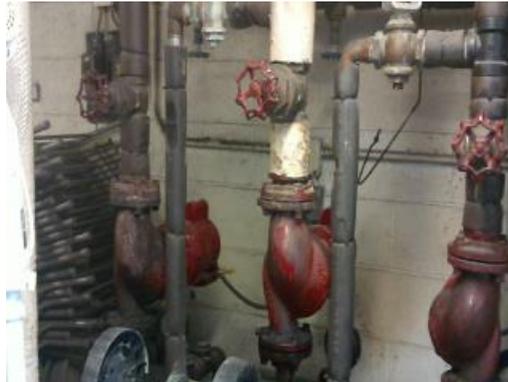
Aged Pumps

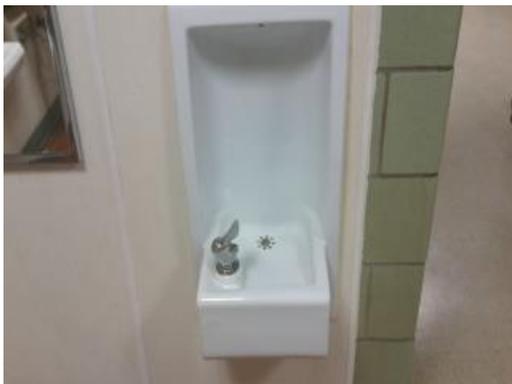
Non-Refrigerated Drinking Fountain

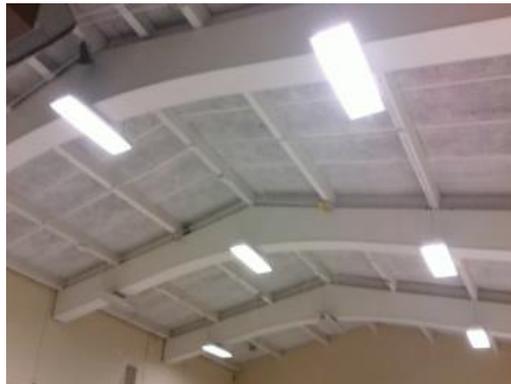
Gym Ceiling

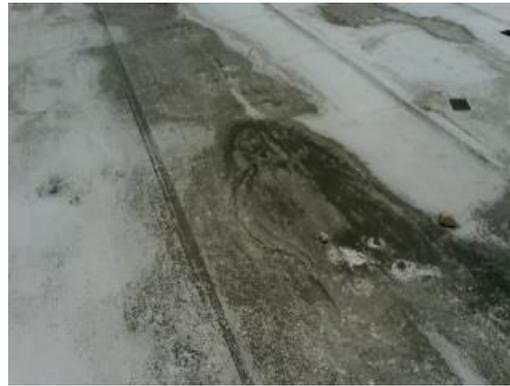
Evidence Of Ponding On Roof

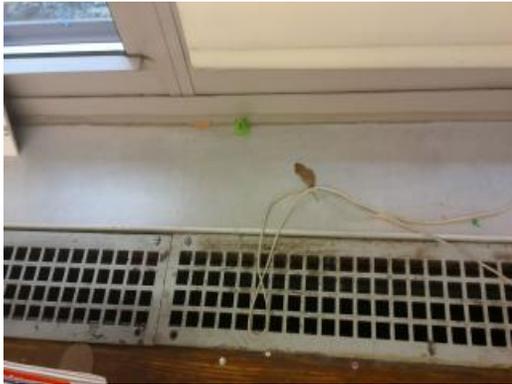
Aged Radiator

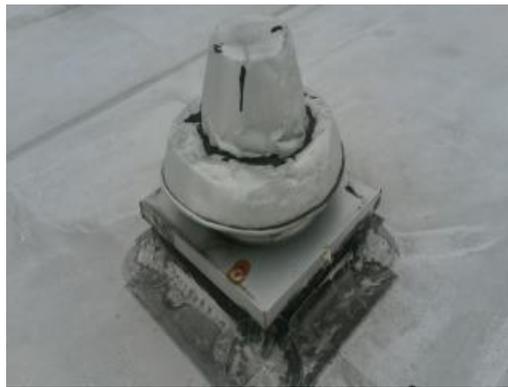
Damaged Roof Exhaust Hood

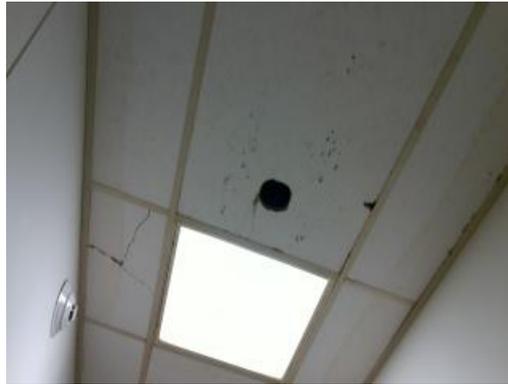
Damaged Ceiling Tile

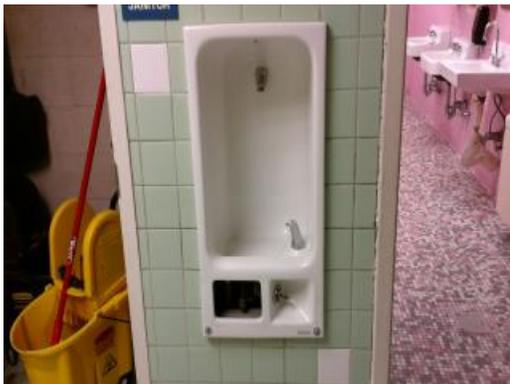
Aged Drinking Fountain

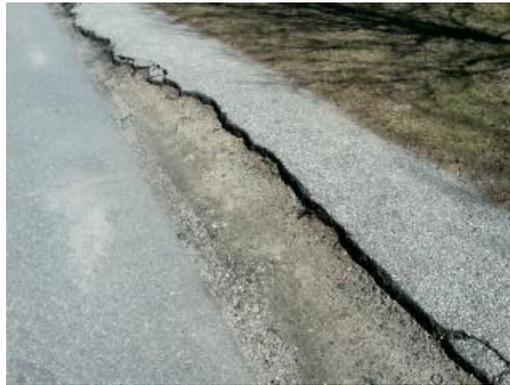
Cracked Pedestrian Paving

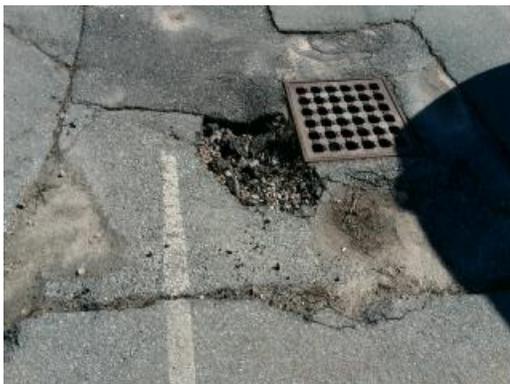
Damaged Asphalt In Parking Lot

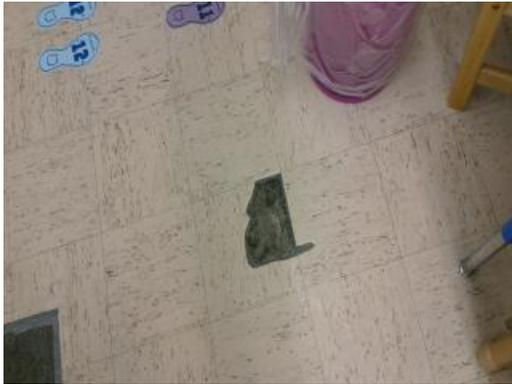
Damaged VCT Floor

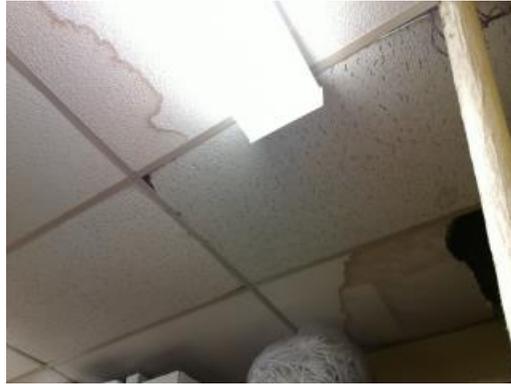
Stained Ceiling Tiles

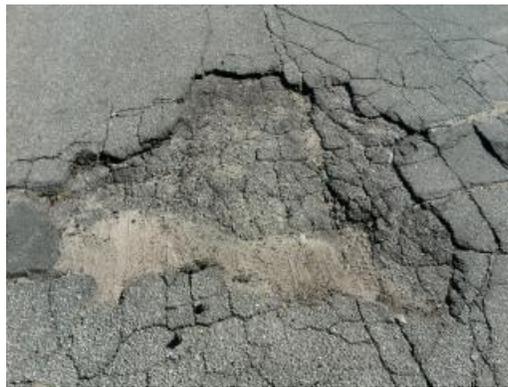
Damaged Pavement In Parking Lot

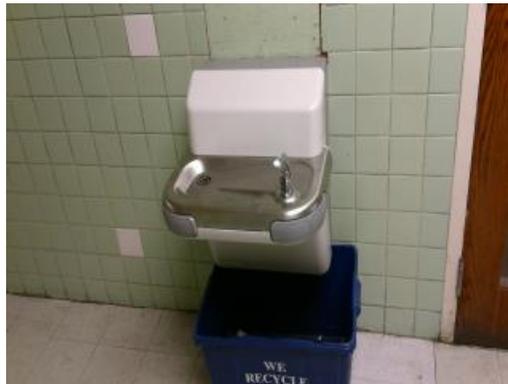
Leaking Drinking Fountain

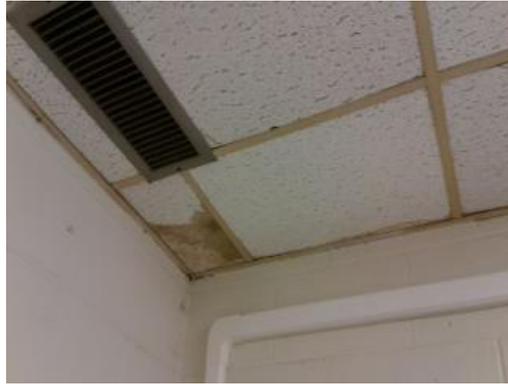
Stained Ceiling Grid

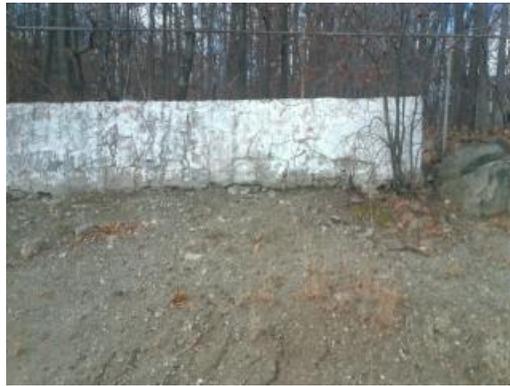
Stone Fencing

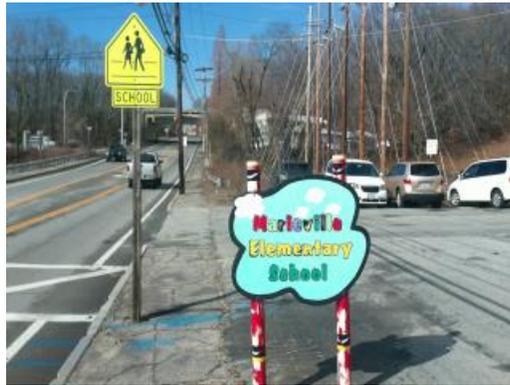
School Signage And Proximity To Highway

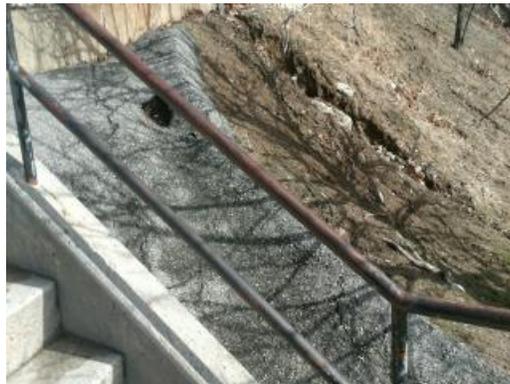
Rusted & Worn Stairwell Railing

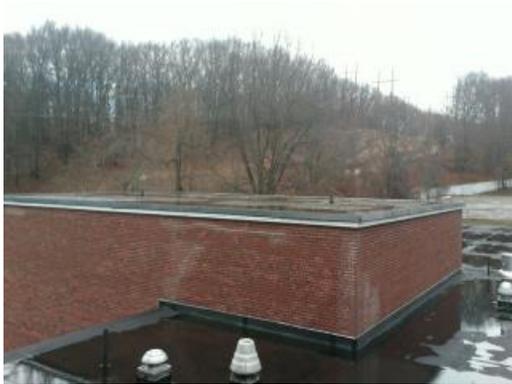
Roof Ponding - Gym Area

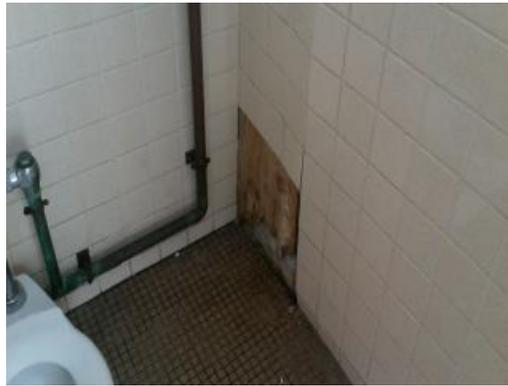
Damaged Tile Wall In Boys Restroom

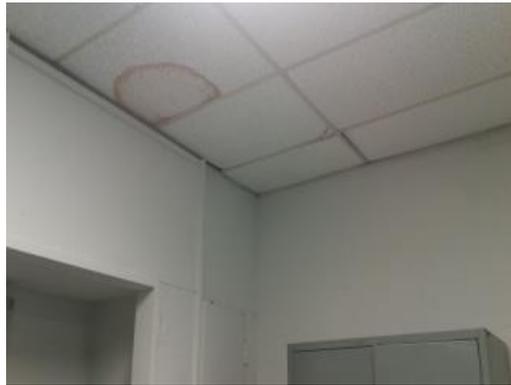
Stained Ceiling Tile

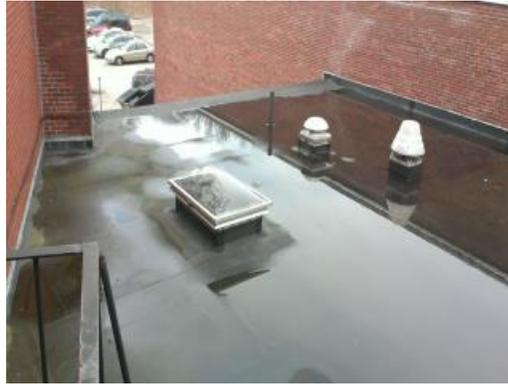
Ponding On Roof

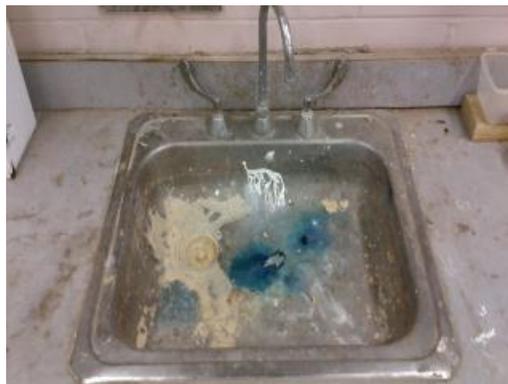
Corroded Lavatory

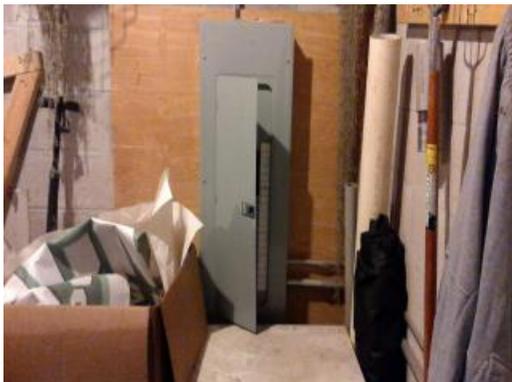
Original Panelboard

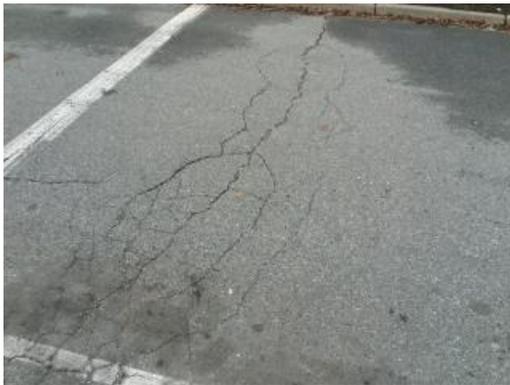
Cracked Asphalt Pavement

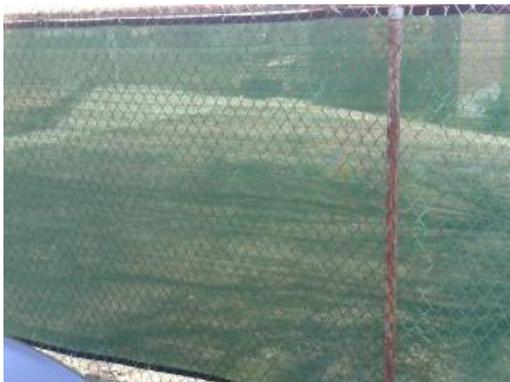
Rusted Fencing

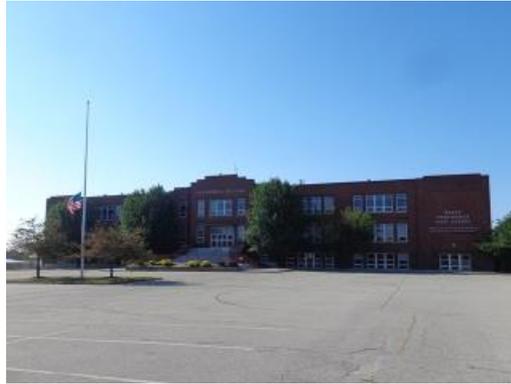
Elevation

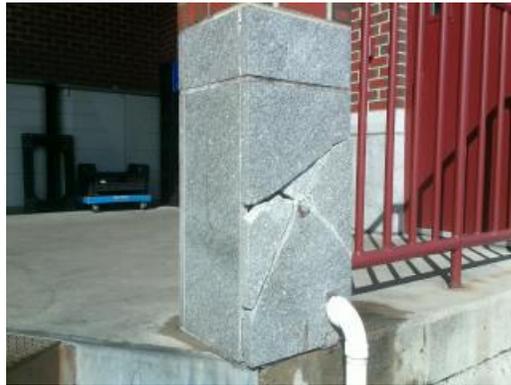
Broken Granite Near Loading Dock

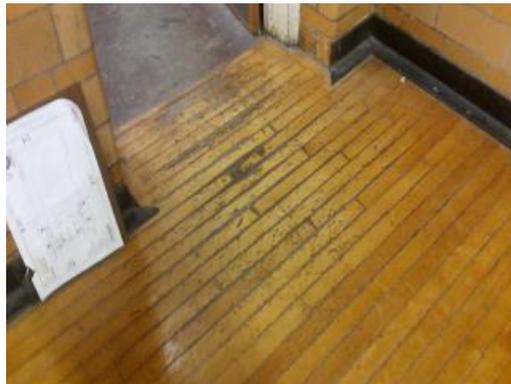
Worn Wood Flooring

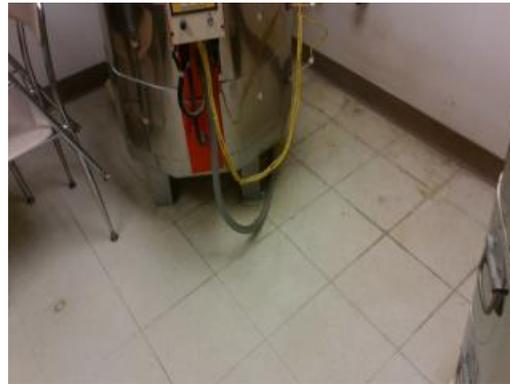
Separating Vinyl Tile Floor

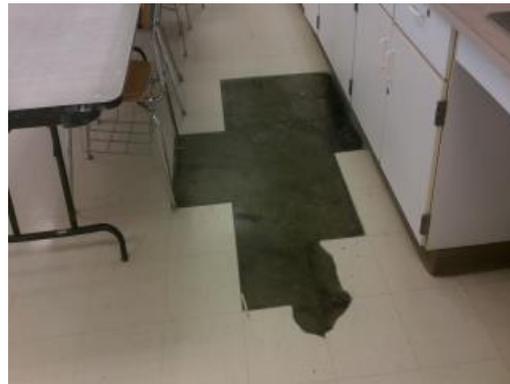
Chipped And Missing VCT

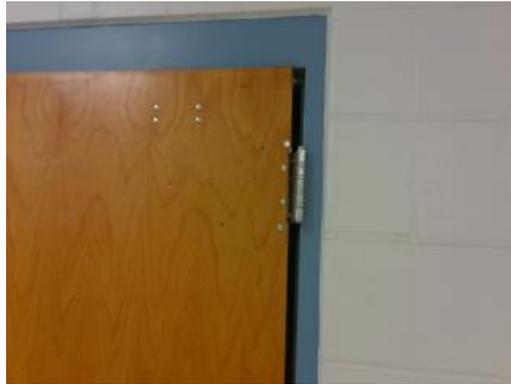
Broken Wood Interior Door

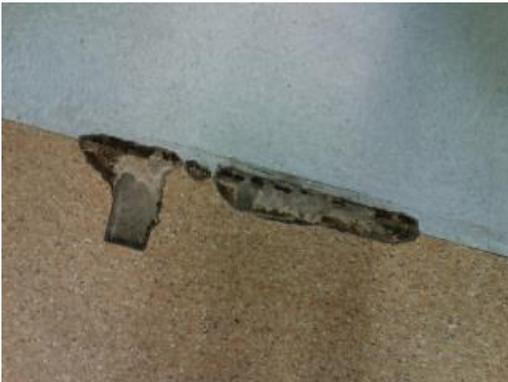
Damaged VCT

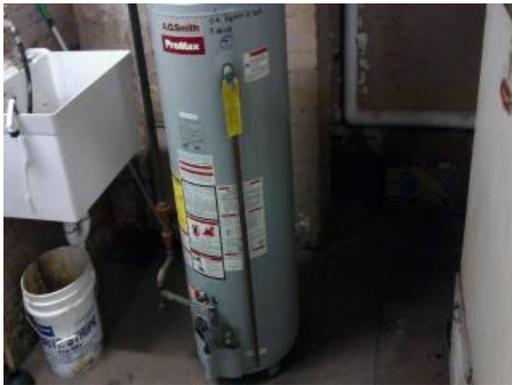
Water Heater

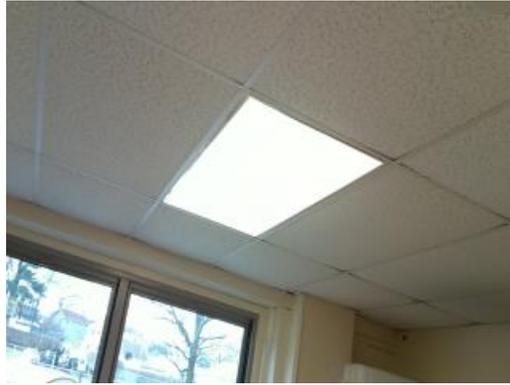
Typical Interior Lighting

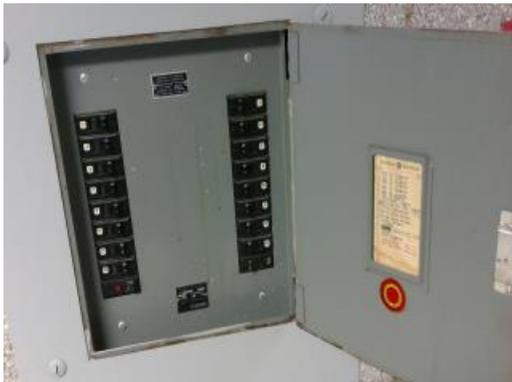
Aged Electrical Panel

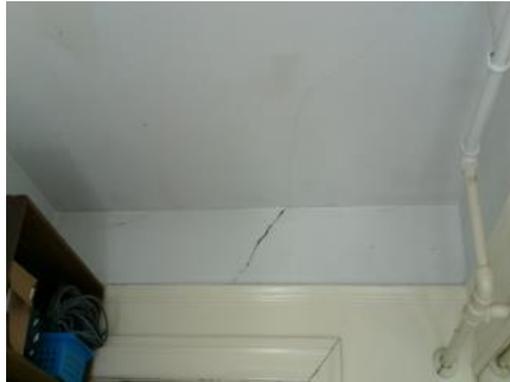
Cracked Ceiling

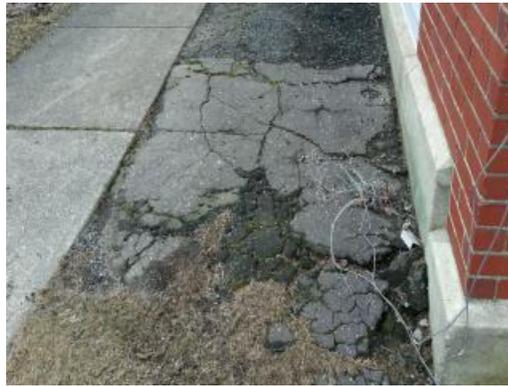
Deteriorated Asphalt Pavement

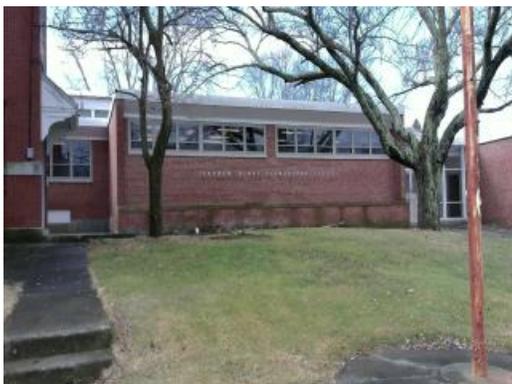
Exterior

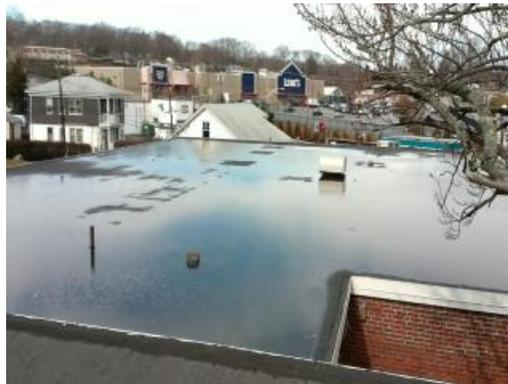
Ponding On Roof

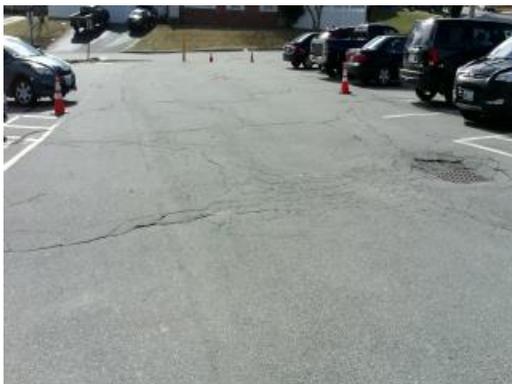
Cracked And Worn Parking Lot Asphalt

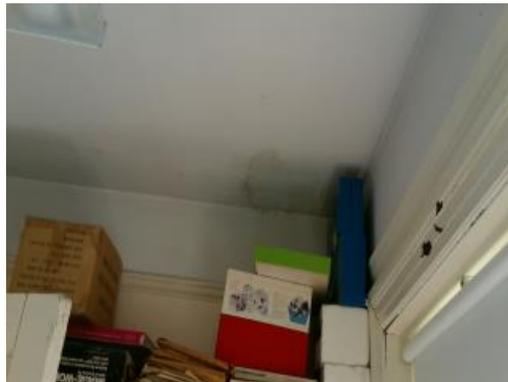
Stained Ceiling

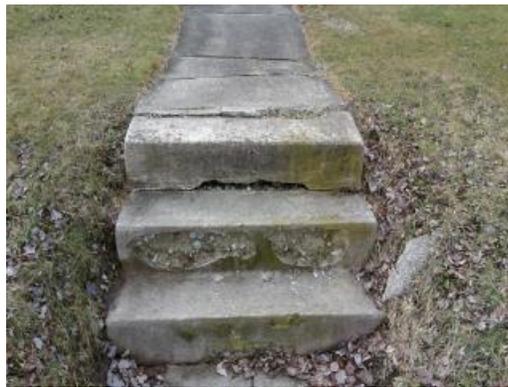
Damaged Exterior Steps
