# South Kingstown

# Facility Condition Assessment

Academic Success Academy, located at 153 School Street in Wakefield, Rhode Island, was built in 1920. It comprises 26,503 gross square feet. Each school across the district was visited three times during the Facility Condition Assessments by three teams of specialists in the spring/summer of 2016.

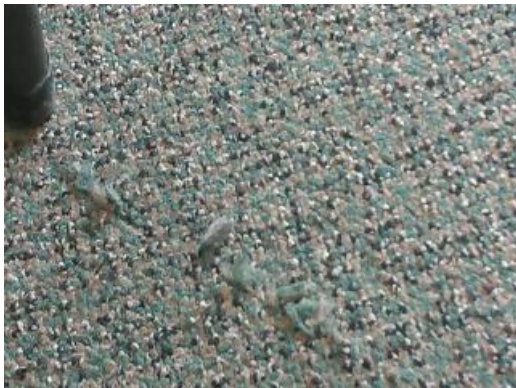
Frayed Carpet

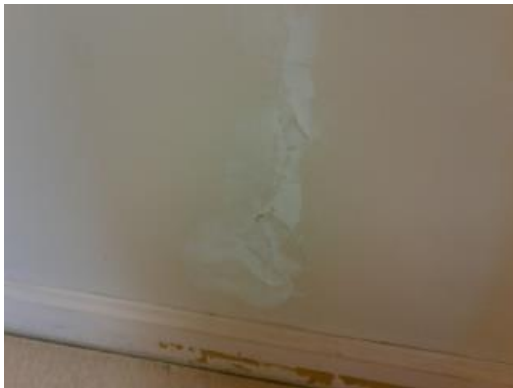
Peeling Paint

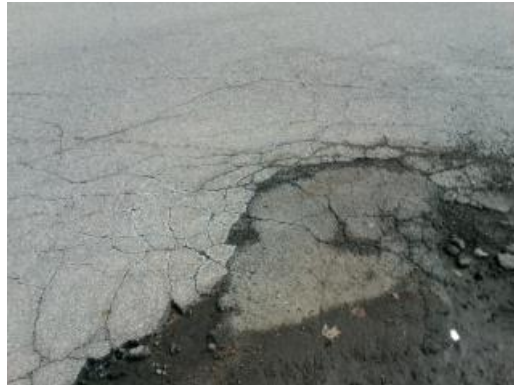
Alligatored Asphalt

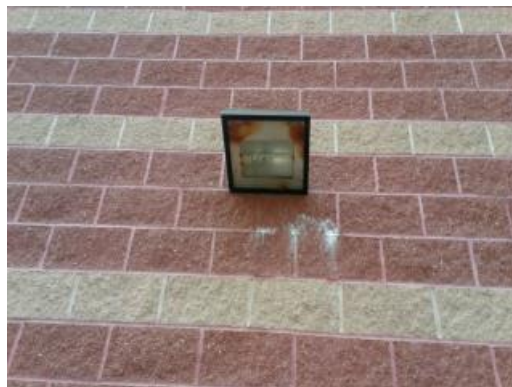
Aged Building Light

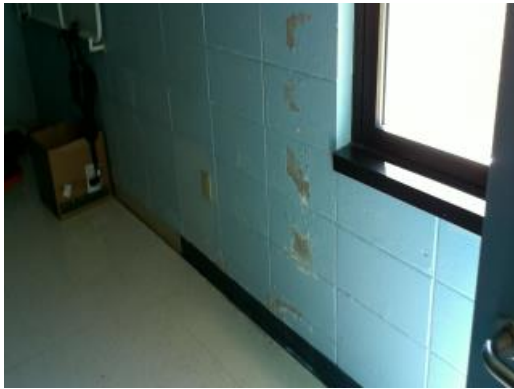
Paint Peeling

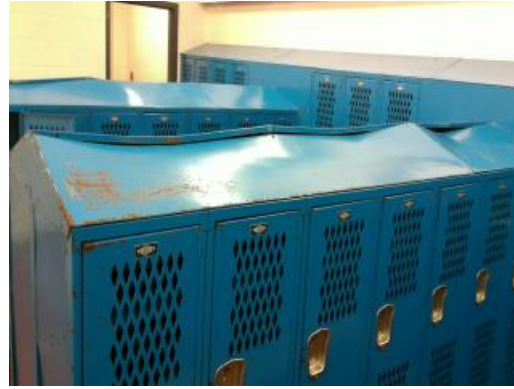
Damaged Lockers

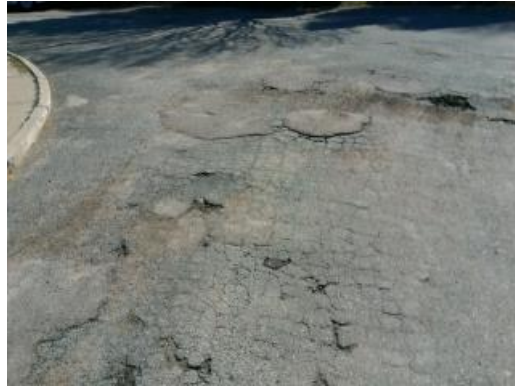
Alligatored Asphalt Paving

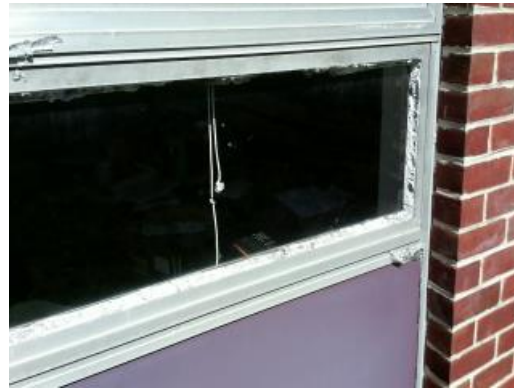
Aged Windows

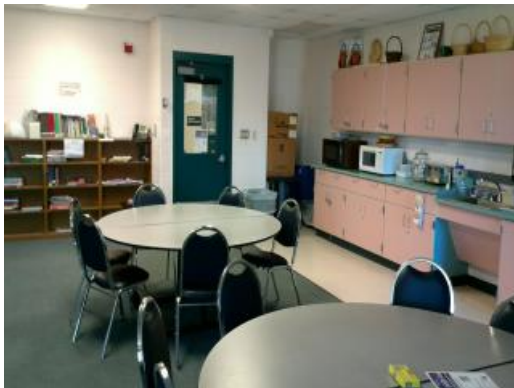
Worn Carpet

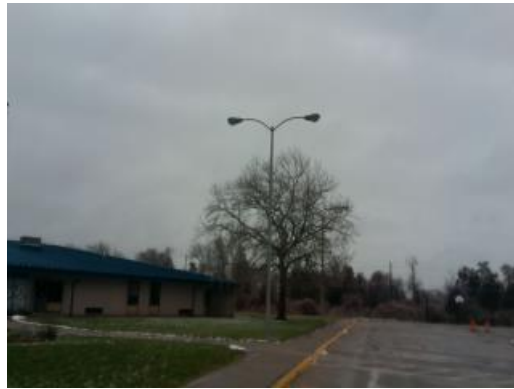
Old Pole Lights

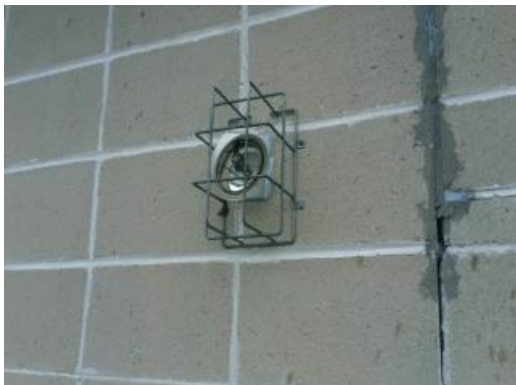
Low Efficiency Building Mounted Light

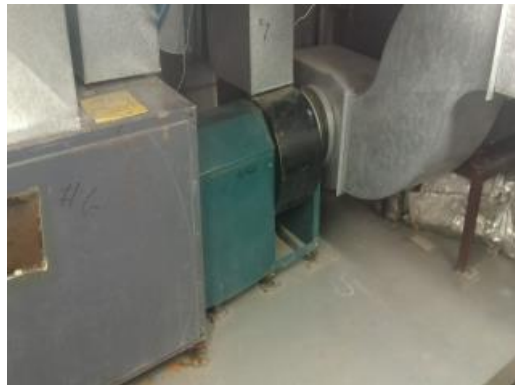
Exhaust Fan

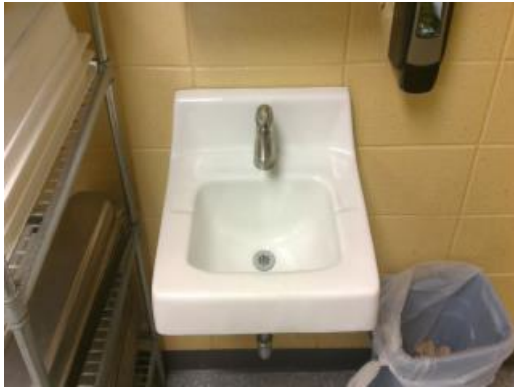
Handwashing Kitchen Sink

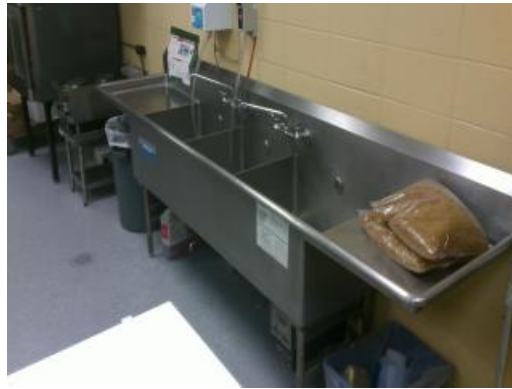
Stainless Kitchen Sinks

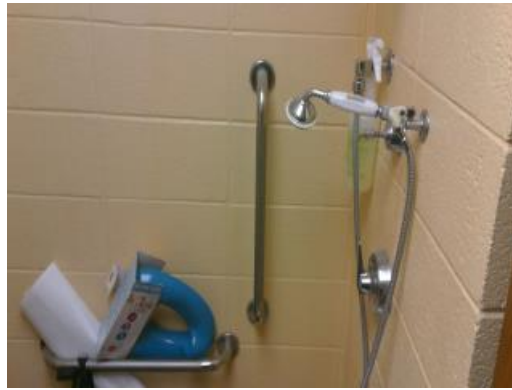
Nurse's Office Shower

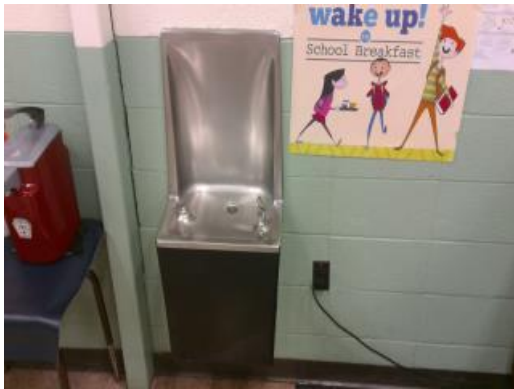
Refrigerated Drinking Fountain With Non-Functional Compressor

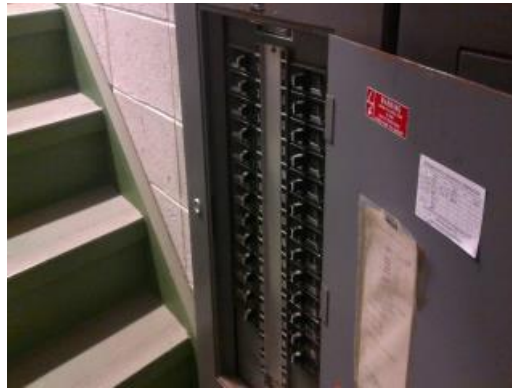
Aged Panel

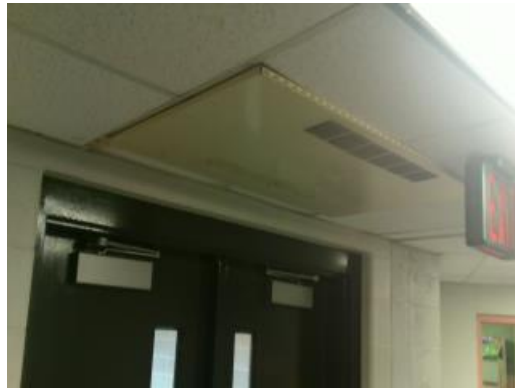
1991 Fan Coil

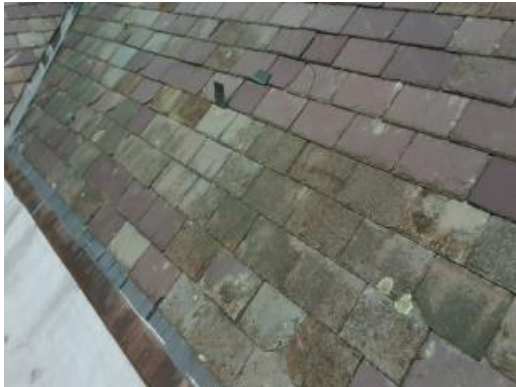
Slate With Mold

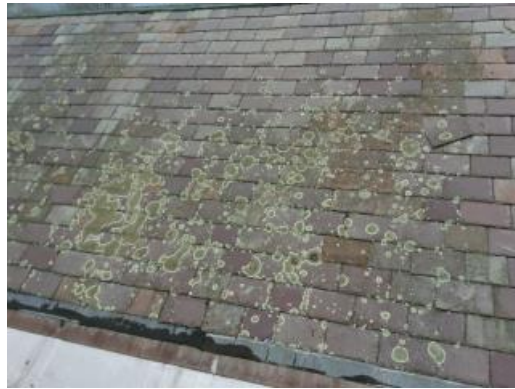
Mold

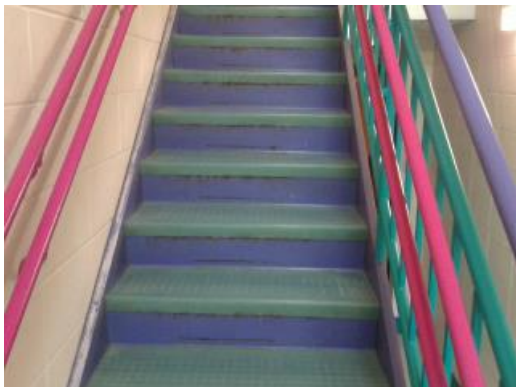
Worn Rubber Flooring

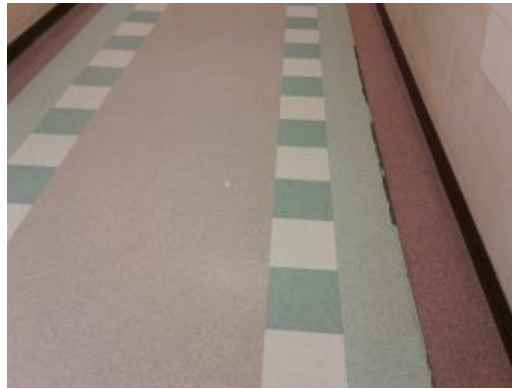
Chipped VCT

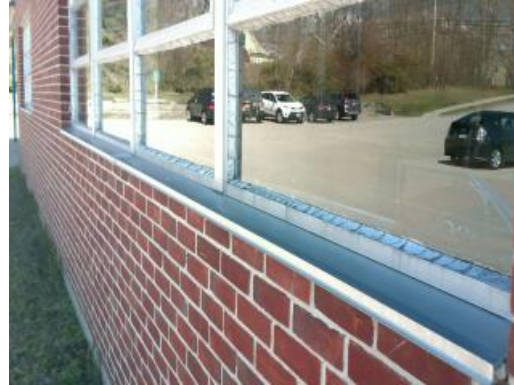
Original Single Pane Windows

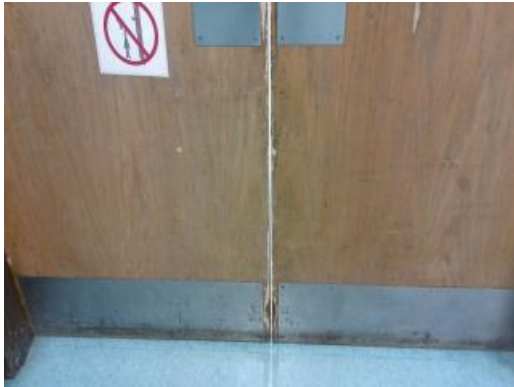
Scratched Doors

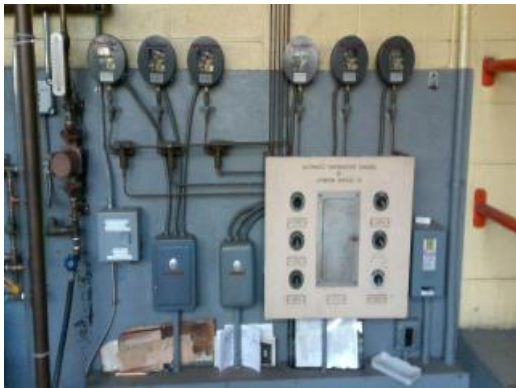
Pneumatic System

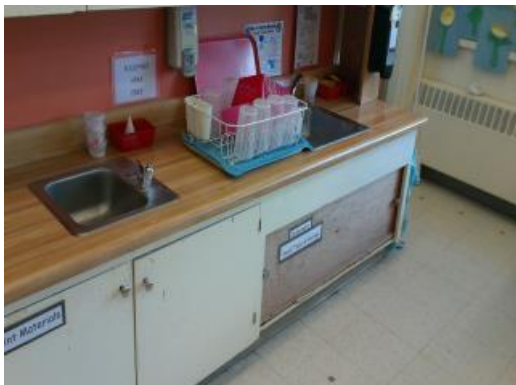
Damaged Casework

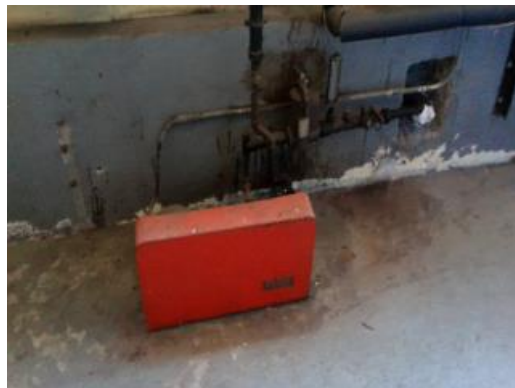
Abandoned Equipment

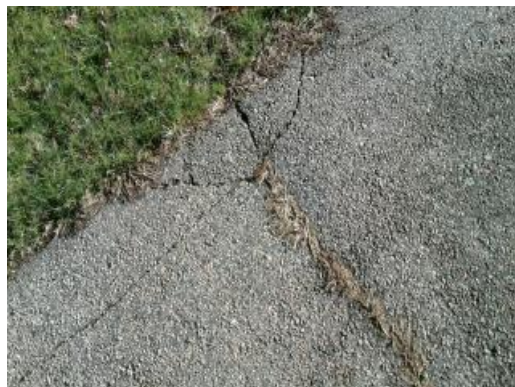
Cracked Asphalt

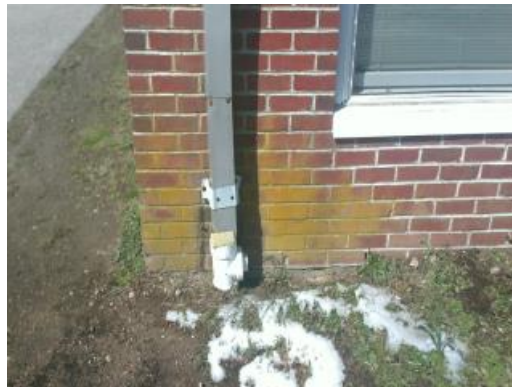
Leaking Downspout

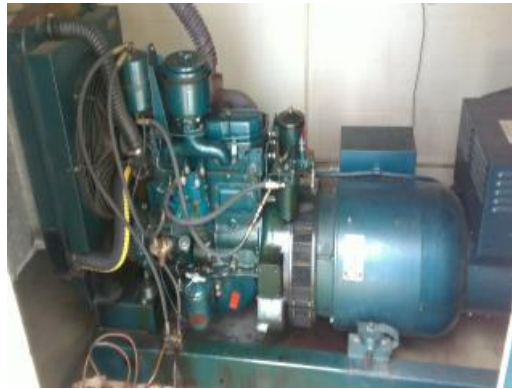
Aged Generator

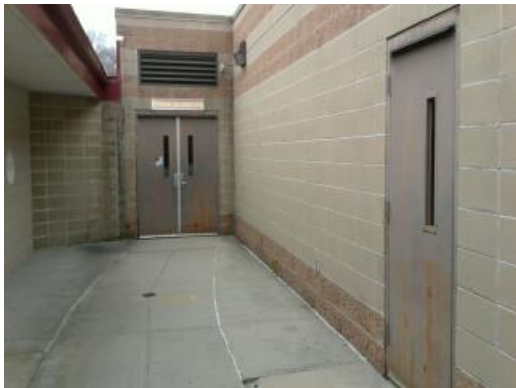
Weathered And Corroded Exterior Doors

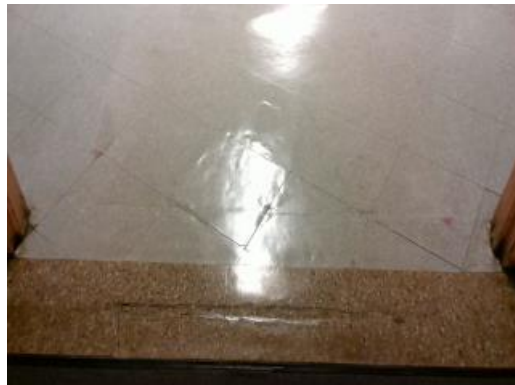
Curling VCT Flooring

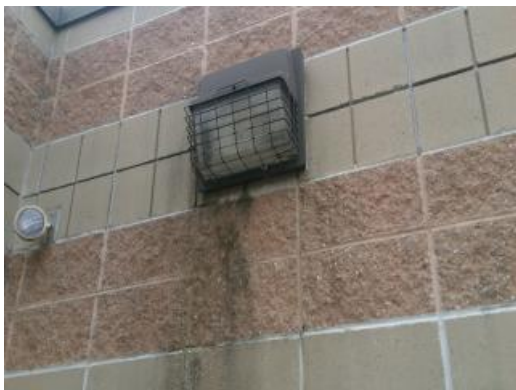
Canopy Mounted Fixture

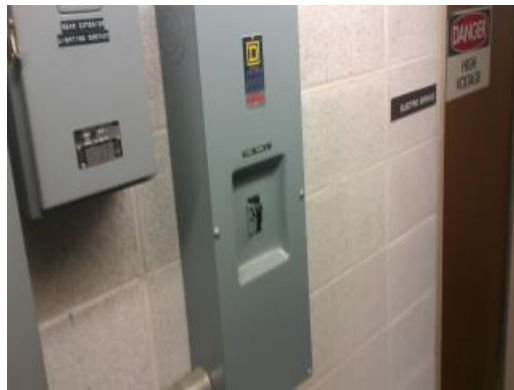
Aged Building Mounted Light

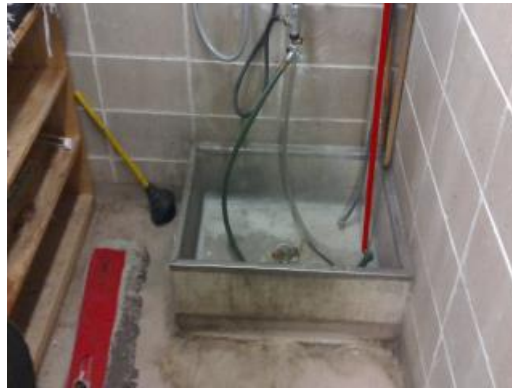
Aged Service Sink

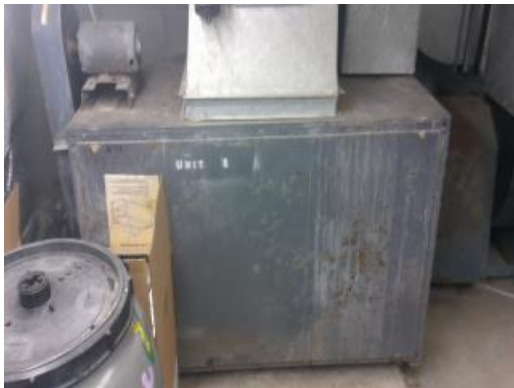
Aged Make Up Air Unit

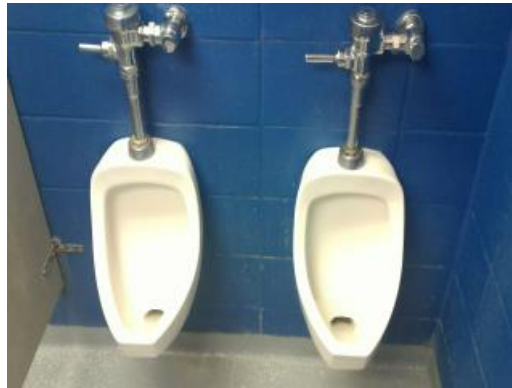
Typical Urinals

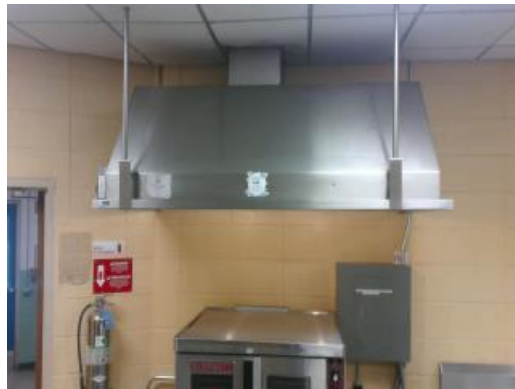
Deficiency	Category	Qty	UoM	Priority	Repair Cost	ID
Fire Alarm Is Missing Or Inadequate (NFPA 72 and NFPA 101, Section 9.6)	Code Compliance	43,552	SF	1	\$126,791	9465
Replace Kitchen Exhaust Hood <b>Note:</b> Kitchen exhaust hood is aged. Filters are clogged and the bearings are very noisy.	Capital Renewal	1	Ea.	1	\$15,857	9479
<b>Sub Total for System</b>		<b>2</b>	<b>items</b>		<b>\$142,648</b>

Kitchen Exhaust

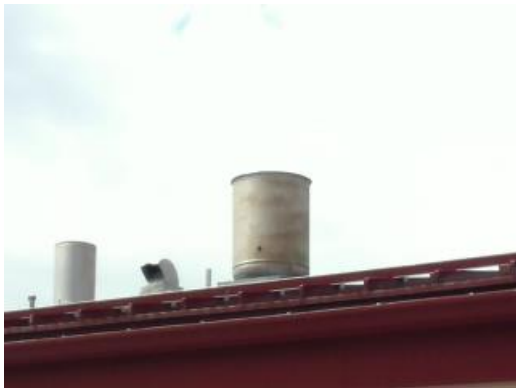
Weathered Exhaust
