# Facility Condition Assessment

Bristol Warren - Mt. Hope High School

June 2017

199 Chestnut Street, Bristol, RI 02809

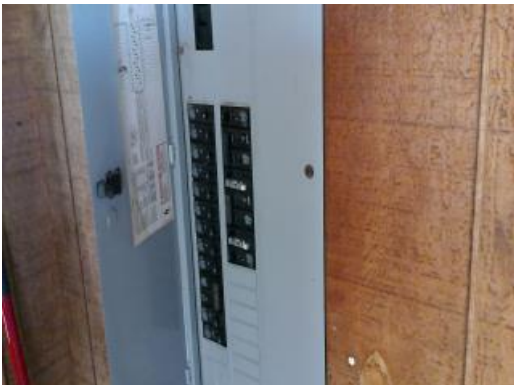
Aged Panelboard

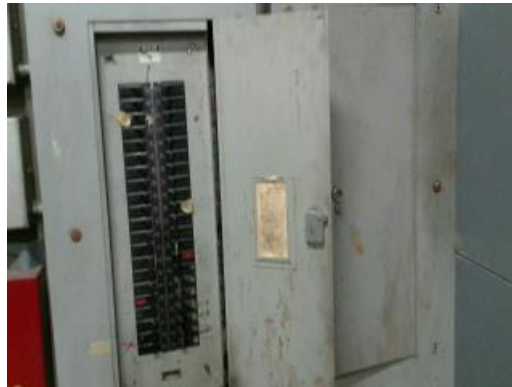
Aged Panelboard

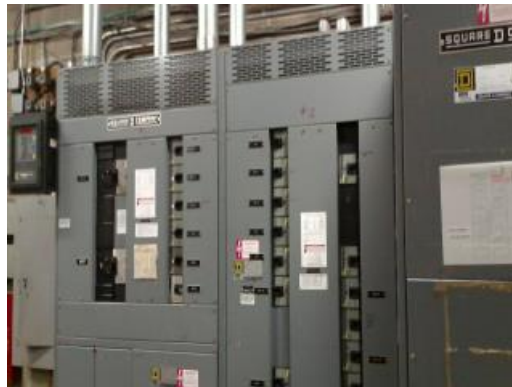
Switchboard

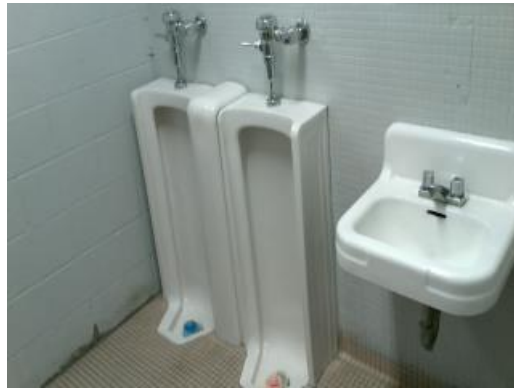
Typical Urinal Fixtures
