Facility Condition Assessment

Cumberland - Cumberland High School

June 2017

2600 Mendon Road, Cumberland, RI 02864

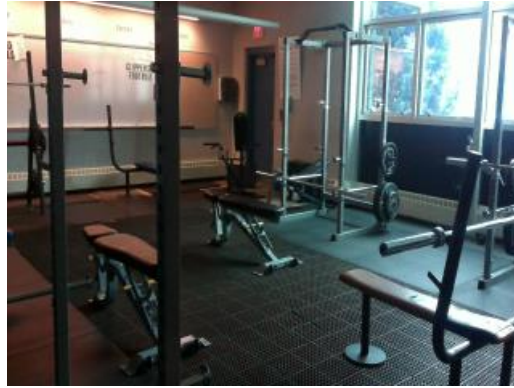
Weight Room

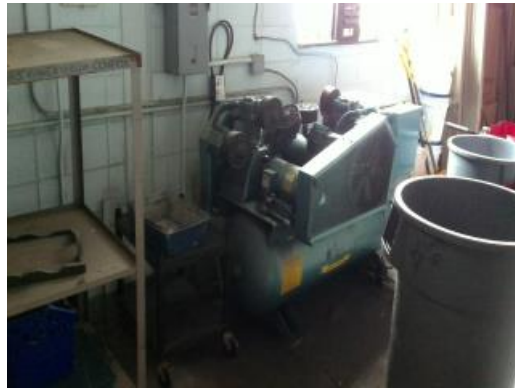
Air Compressor

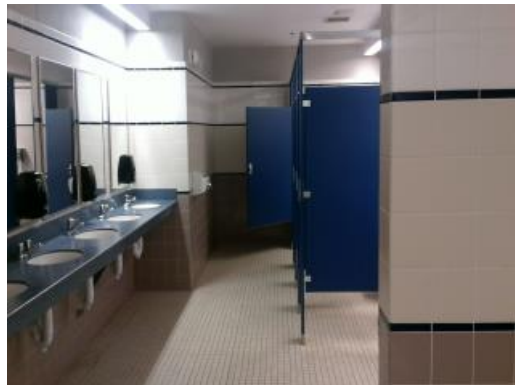
Restroom Finishes

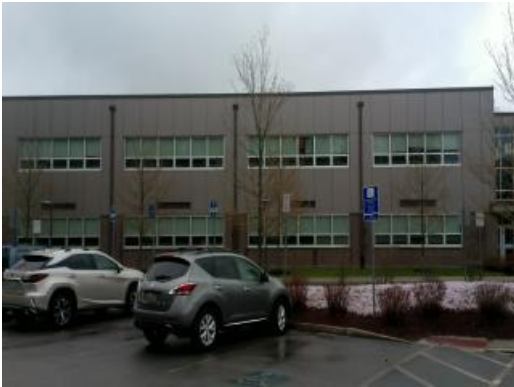
Exterior Finishes

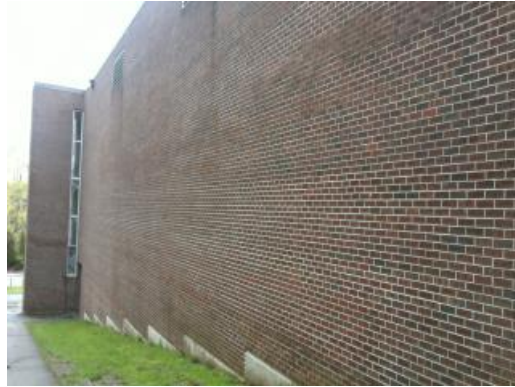
Exterior Brick

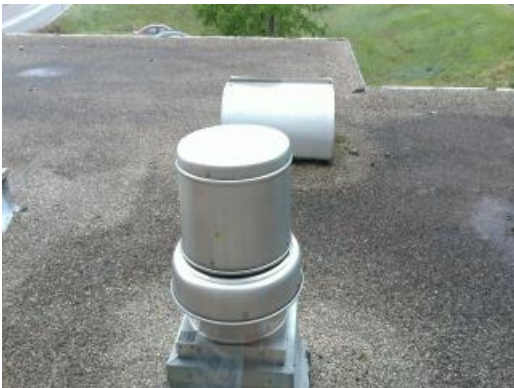
Exhaust Fan

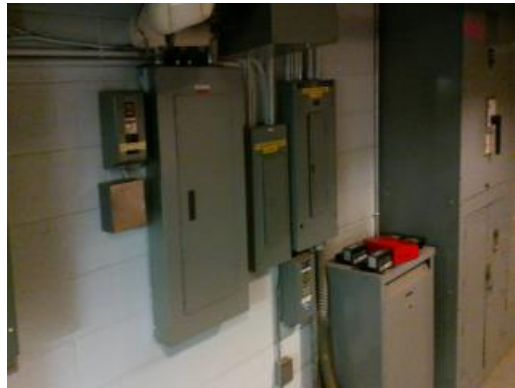
Panelboards

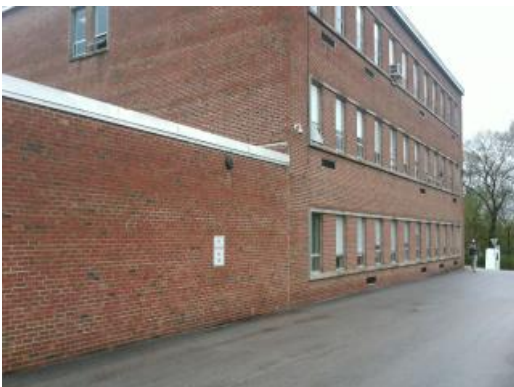
Brick Exterior

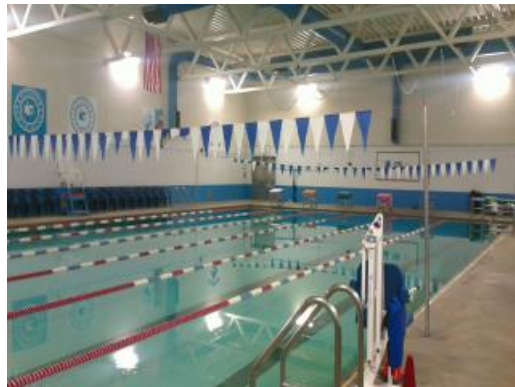
Pool

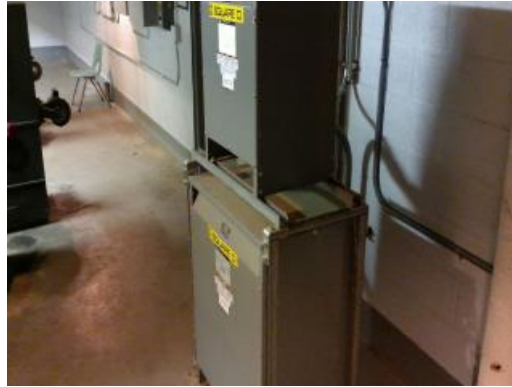
Transformer

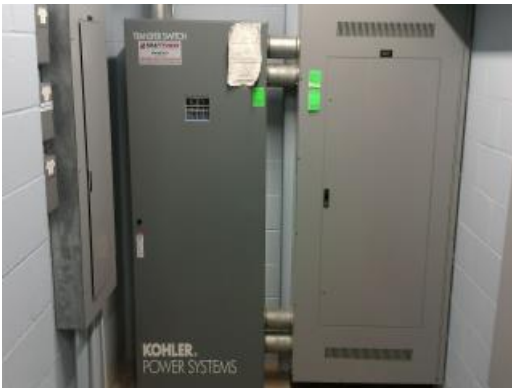
Transfer Switch

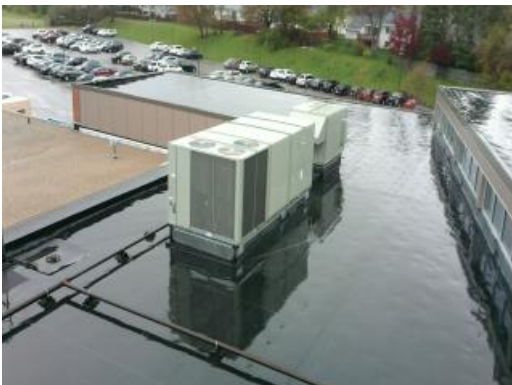
Rooftop AHU

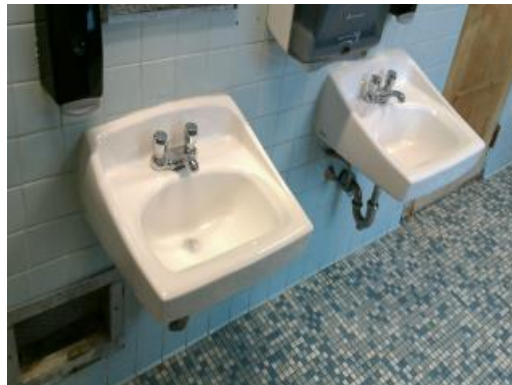
Restroom Lavatories

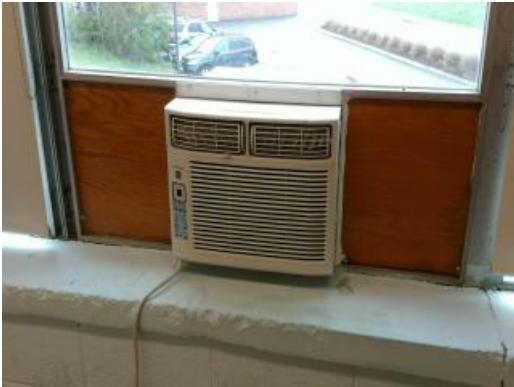
Window Unit

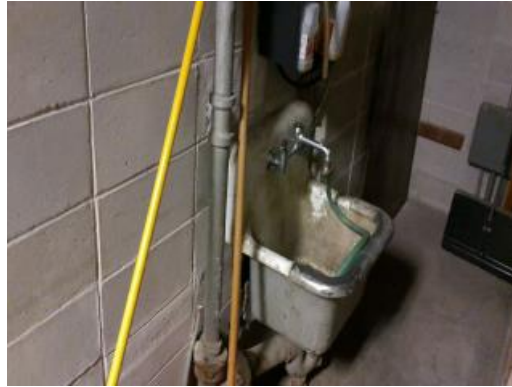
Mop Sink

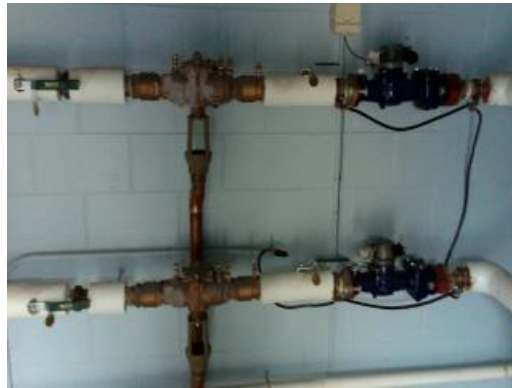
Backflow Preventers

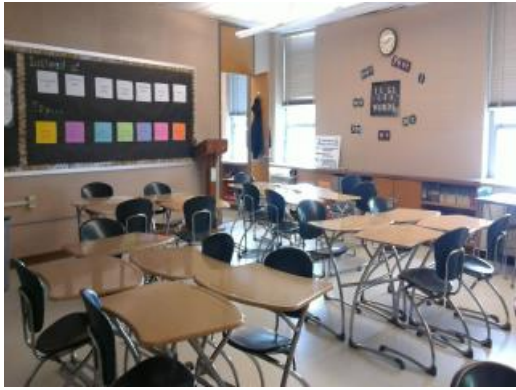
Typical Classroom
