# Facility Condition Assessment

North Smithfield - Dr. Harry L. Halliwell Memorial School

June 2017

358 Victory Highway, Slatersville, RI 02876

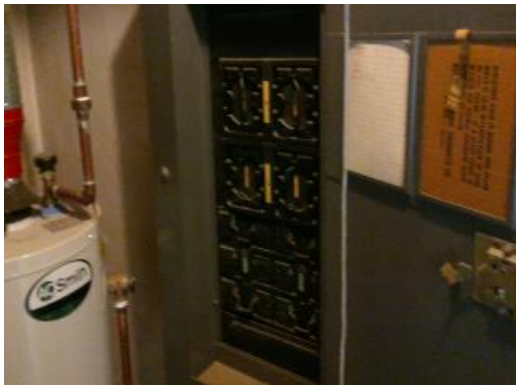
Aged Panelboard

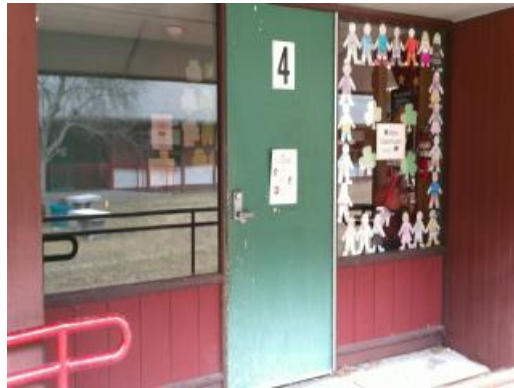
Exterior Door

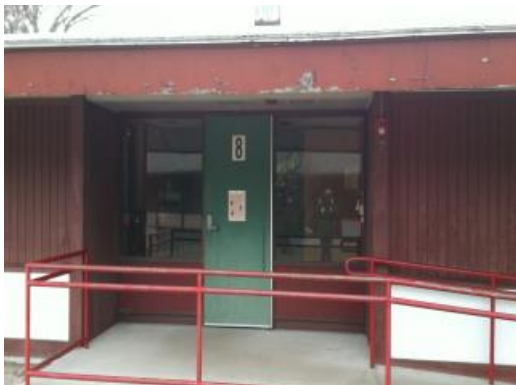
Exterior Door

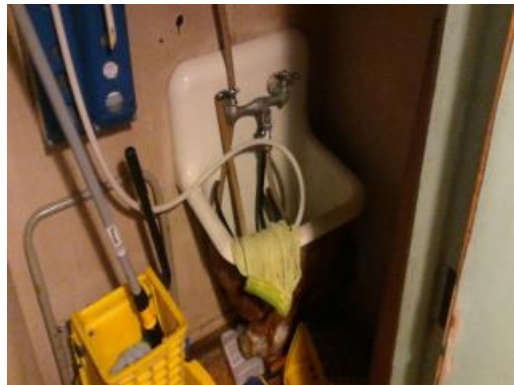
Typical Service Sink

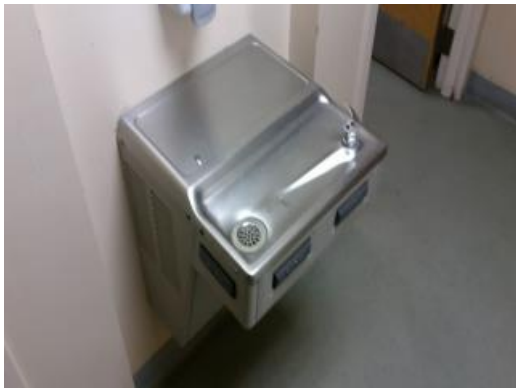
Water Fountain

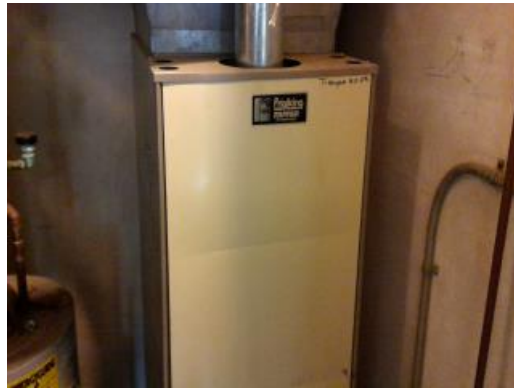
Furnace

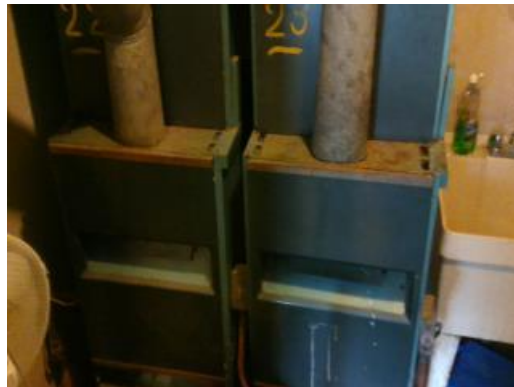
Aged Furnaces

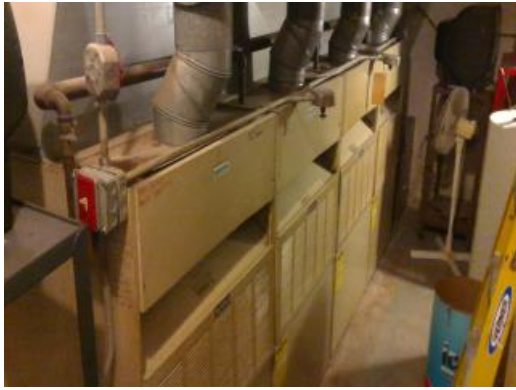
Gym Furnaces

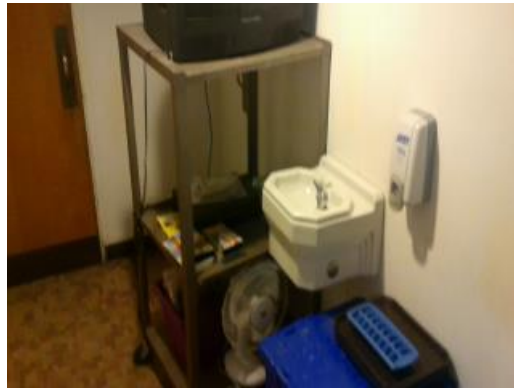
Drinking Fountain
