Facility Condition Assessment

Tiverton - Tiverton High School

June 2017

100 North Brayton Road, Tiverton, RI 02878

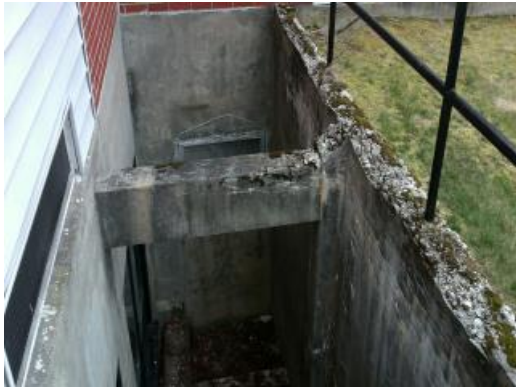
Courtyard Window Well

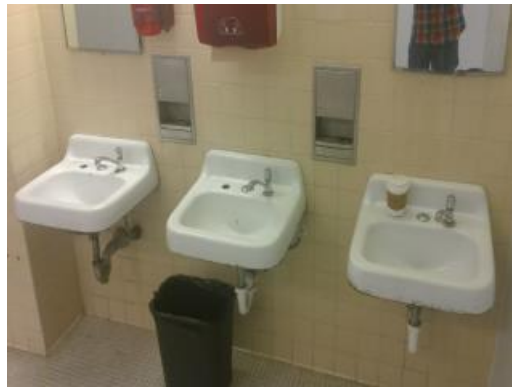
Original Lavatories

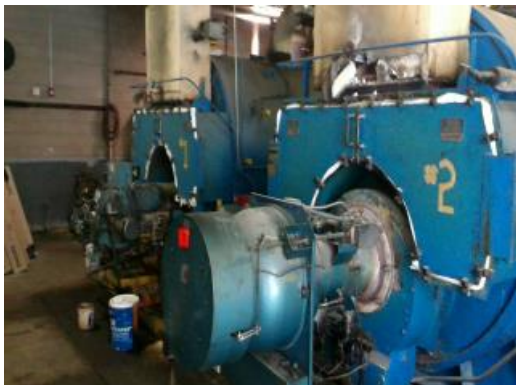
Steel Tube Boilers

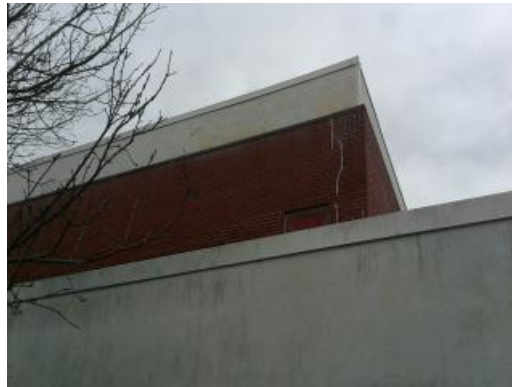
Peeling Stucco
